## Burnley Pendle Growth Corridor Junction H Rose Grove Junction

Lancashire County Council

Stage 1 Road Safety Audit

CA307/ 1322|0

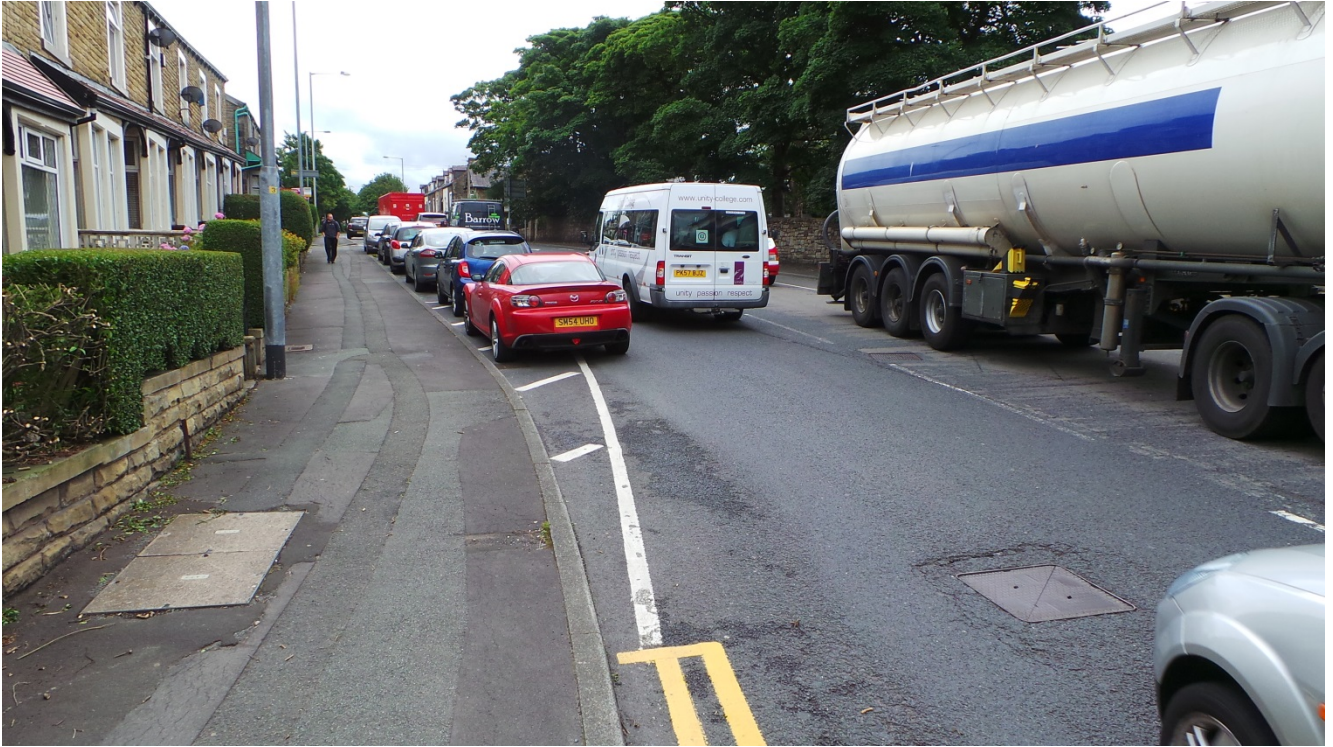
Concern is expressed that the extension of the parking bay on the southbound side of Rossendale Road is likely to reduce the available road space for large vehicles travelling south on Rossendale Road, causing them to come into conflict with parked vehicles. (Refer to photo A.1).

Concern is expressed that the extended parking bay on the southbound side of Rossendale Road will restrict the available lane width for vehicles, causing them to overrun into the northbound carriageway.

Figure A.1 : Narrow lane width, due to proposed parking bay and existing parking on Rossendale Road, looking north

It is recommended that the extents of the parking bay are modified as part of the detailed design stage to ensure that there is sufficient carriageway space for southbound vehicles to pass without coming into conflict with either parked or northbound vehicles.

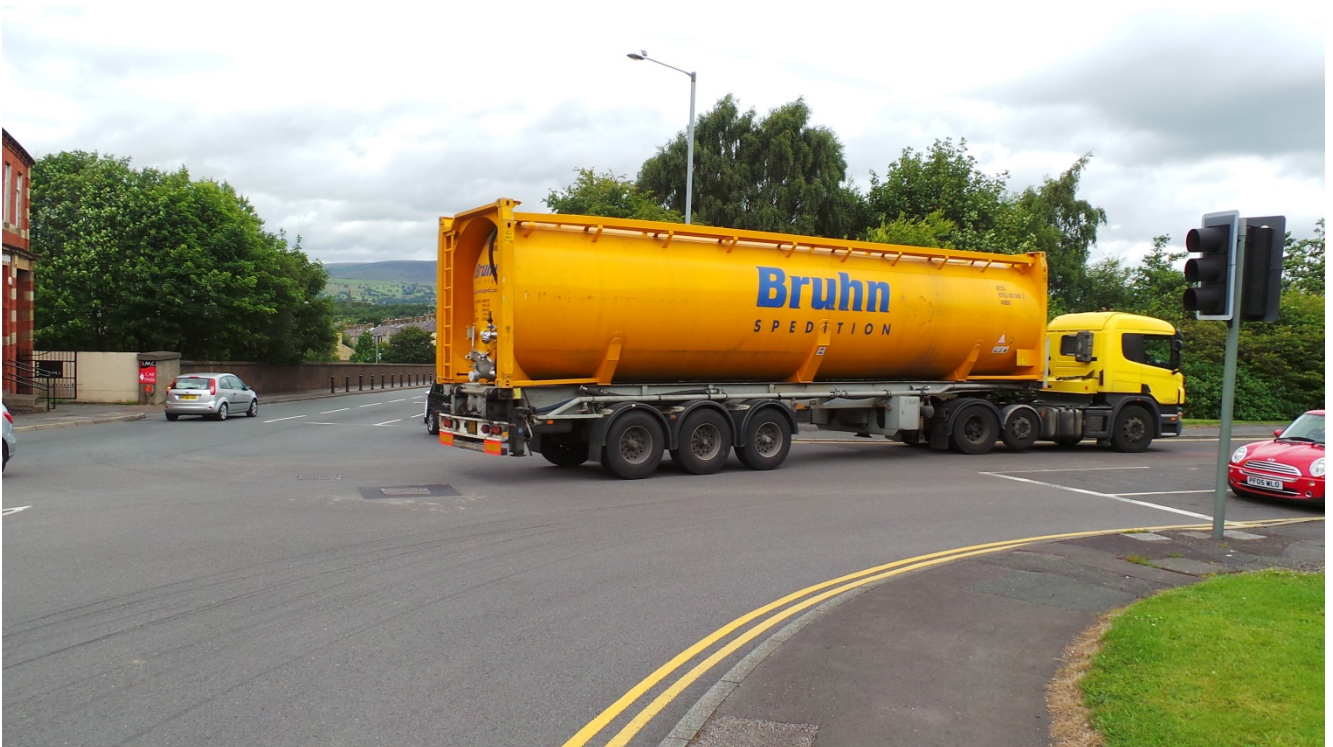
Figure A.2 : Articulated lorry turning right into Accrington Road from Rossendale Road

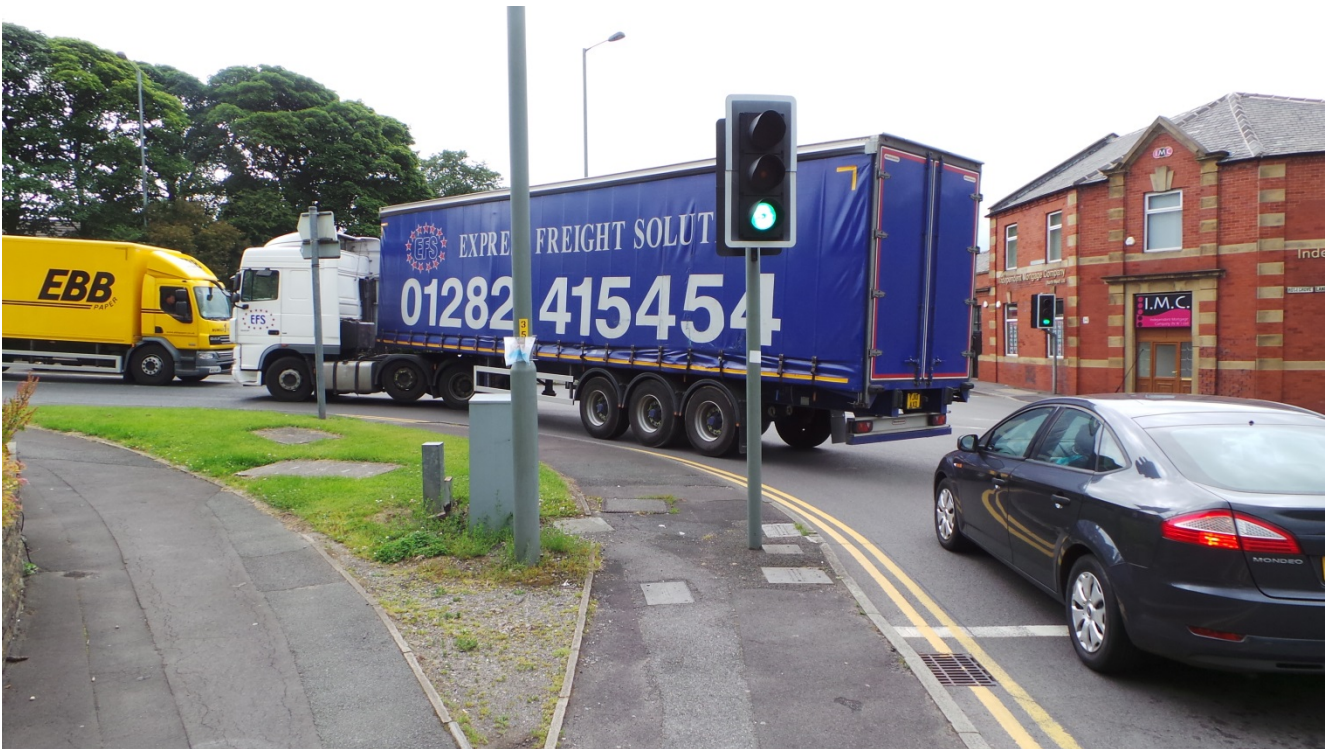
Concern is expressed from observations on site that the existing path of articulated lorries turning left from Accrington Road, south into Rossendale Road, is tight and does not leave a significant margin for error between the offside of the cab and vehicles travelling north on Rossendale Road. Furthermore, it was noted that the rear of HGV trailers overrun the existing nearside kerblines. It is noted from the drawing that at this location there is to be a proposed pedestrian crossing. The drawings provided do not indicate whether this existing kerblines will be modified to accommodate larger vehicles turning at this location. Should this kerblines not be modified, then there is a risk that HGV's may come into conflict with pedestrians waiting to cross at this location resulting in serious injury. (Refer to photo A.3).

Concern is expressed that the pedestrian crossing location is at risk of being overrun by large vehicles/HGV's.

Figure A.3 : Articulated lorry turning left in to Rossendale Road from Accrington Road

It is recommended that the turning movements are Auto-tracked including, both left and right into Rossendale Road from Accrington Road to ensure that pedestrians are not put at risk when looking to cross in an east-west direction across Rossendale Road. Furthermore, it is recommended that the width of the existing footway opposite No.s 4 and 6 Rossendale Road is reduced through the relocation of the kerblines to increase carriageway width and reduce the potential for vehicles to mount the footway and come into conflict with pedestrians.

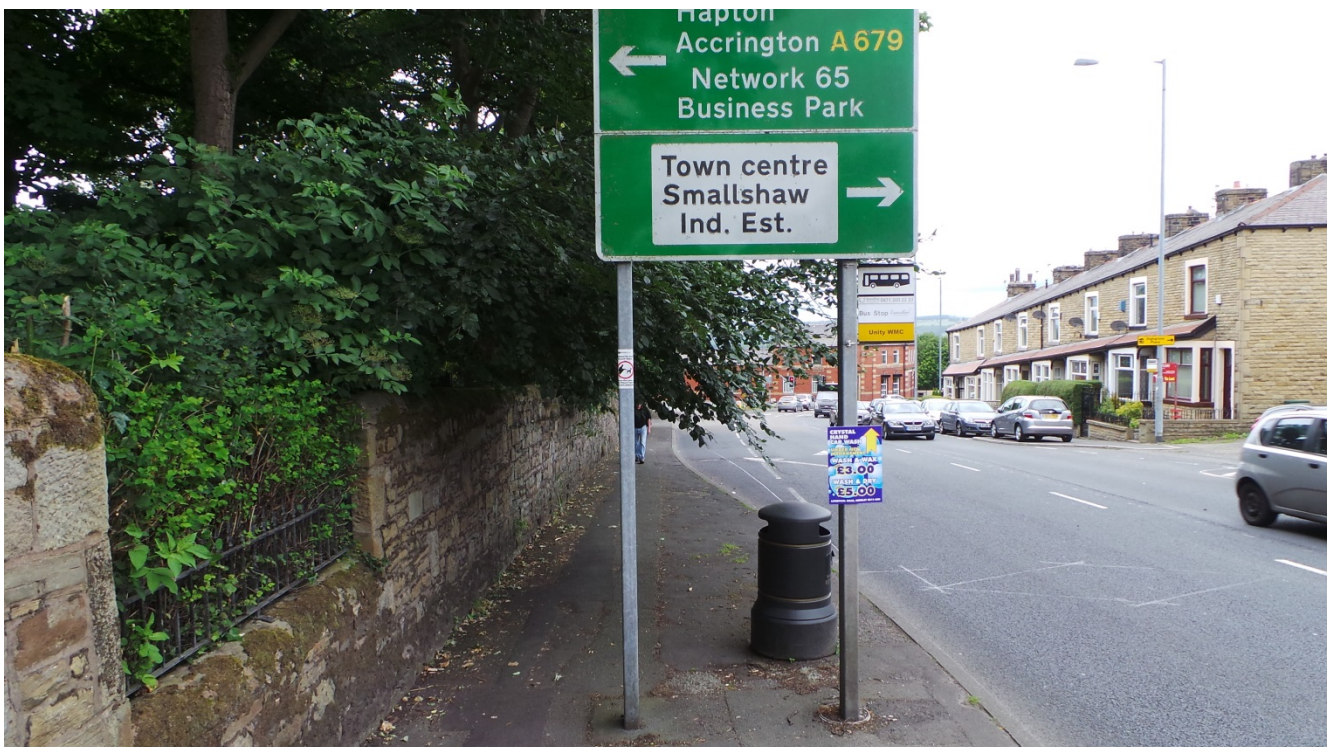
It is noted from site that there are Advance Direction Signs (ADS) on all approaches to the junction. Particular concern is given to the ADS on Rossendale and Accrington Road with regard as to how they will be accommodated due to the change in kerb lines. It is noted that there will be a requirement to provide sufficient clearance to the edge of carriageway and maintain adequate footway space for pedestrians.

Figure A.4 : Advance Direction Sign (ADS) on southbound approach to the junction, which requires relocating

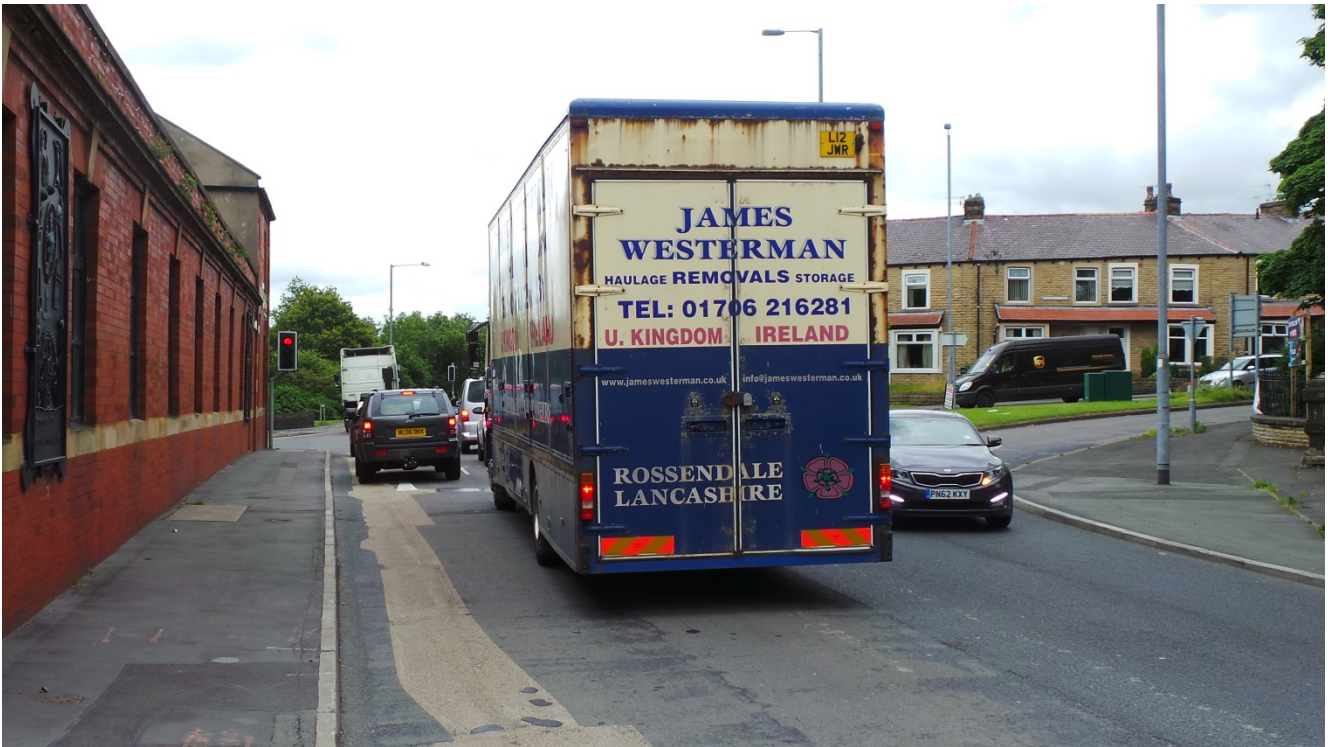
Concern is expressed from observations on site that the existing lane widths on the eastbound approach to the junction are currently too narrow to prevent vehicles mounting the footway on the northern side of the road, to pass queueing traffic looking to turn right, south on Rossendale Road. This manoeuvre is most prevalent when there is little or no traffic queueing to turn left or go straight on. It is unclear from the drawings whether the proposed junction widening will allow for increased road widths. Should the lane widths remain the same, then vehicles currently observed mounting the footway could come into conflict with pedestrians resulting in serious injury. (Refer to photo A.5).

Concern is expressed that there will be insufficient lane widths on Accrington Road to allow eastbound vehicles to travel within their own lane up to and through the junction, without mounting the adjacent footway, coming into conflict with pedestrians.

Figure A.5 : Narrow carriageway width on the eastbound approach to the junction

It is recommended that the detailed design stage provides sufficient consideration to the required lane widths at this junction so far as to ensure vehicles in particular HGV's, do not mount the footway.

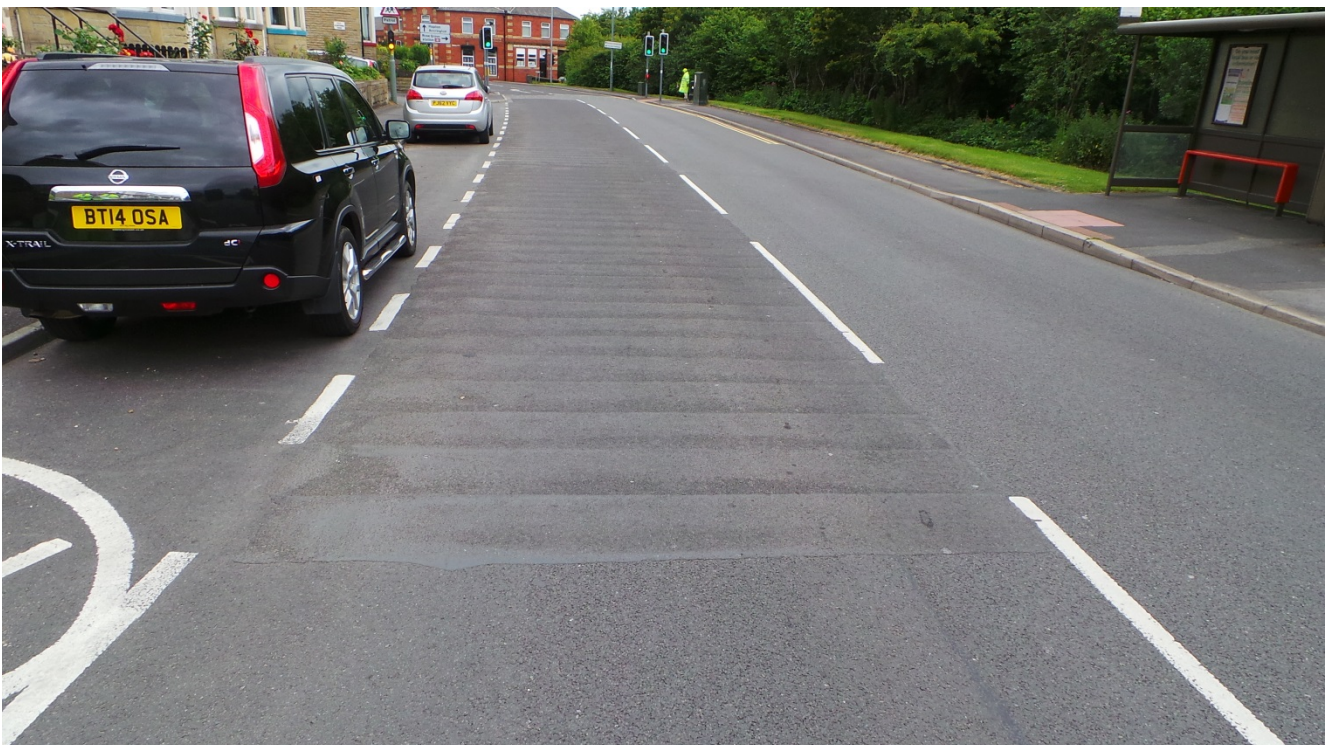
Figure A.6 : Existing High Friction Surfacing (HFS) on the westbound approach to the existing controlled crossing

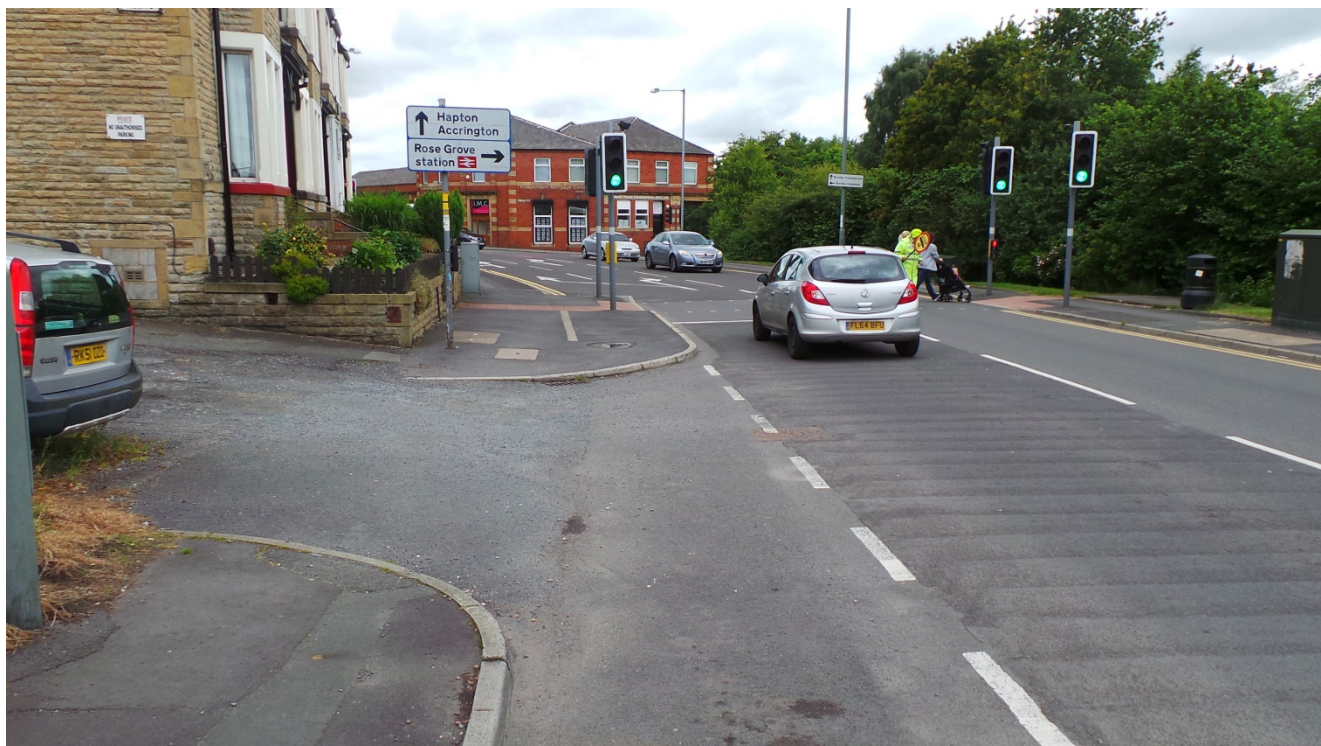
Concern is expressed that there is loose detritus and gravel slipping down the incline from the rough ground between No.s 524a and 524 Accrington Road. At present this is left to collect on the footway, when the new road layout is provided this loose detritus will be in the nearside lane on the approach to the junction and will reduce the braking potential for vehicles in the nearside lane, potentially leading to shunt type collisions. (Refer to photo A.7).

Concern is expressed that loose stones will spill into the carriageway from adjacent unmade land.

Figure A.7 : Area of detritus and access between houses No.s 524a and 524, Accrington Road

It is recommended that the adjacent highway is surfaced to reduce the potential for loose stones to migrate down the slope into the nearside lane.

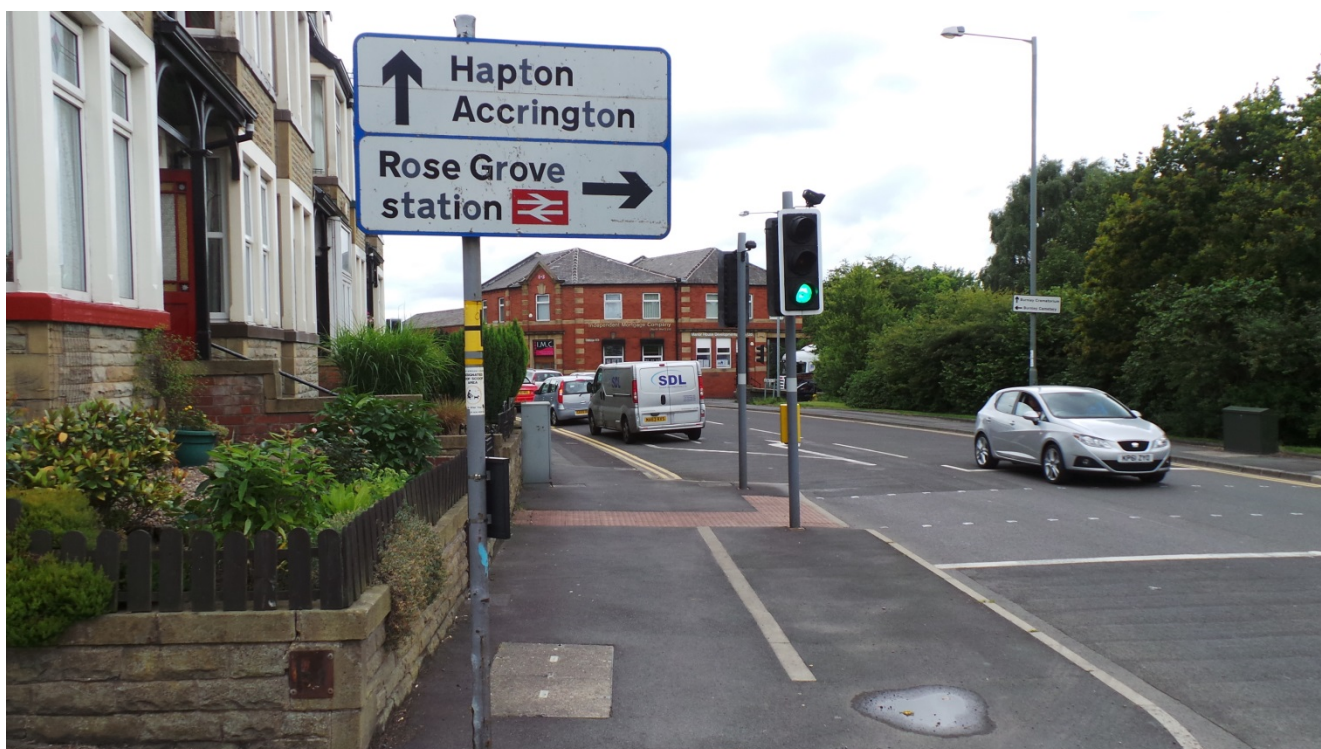
Figure A.8 : Stack Type Sign on westbound approach to the junction, which requires renewal and locating to provide clearance to the edge of carriageway

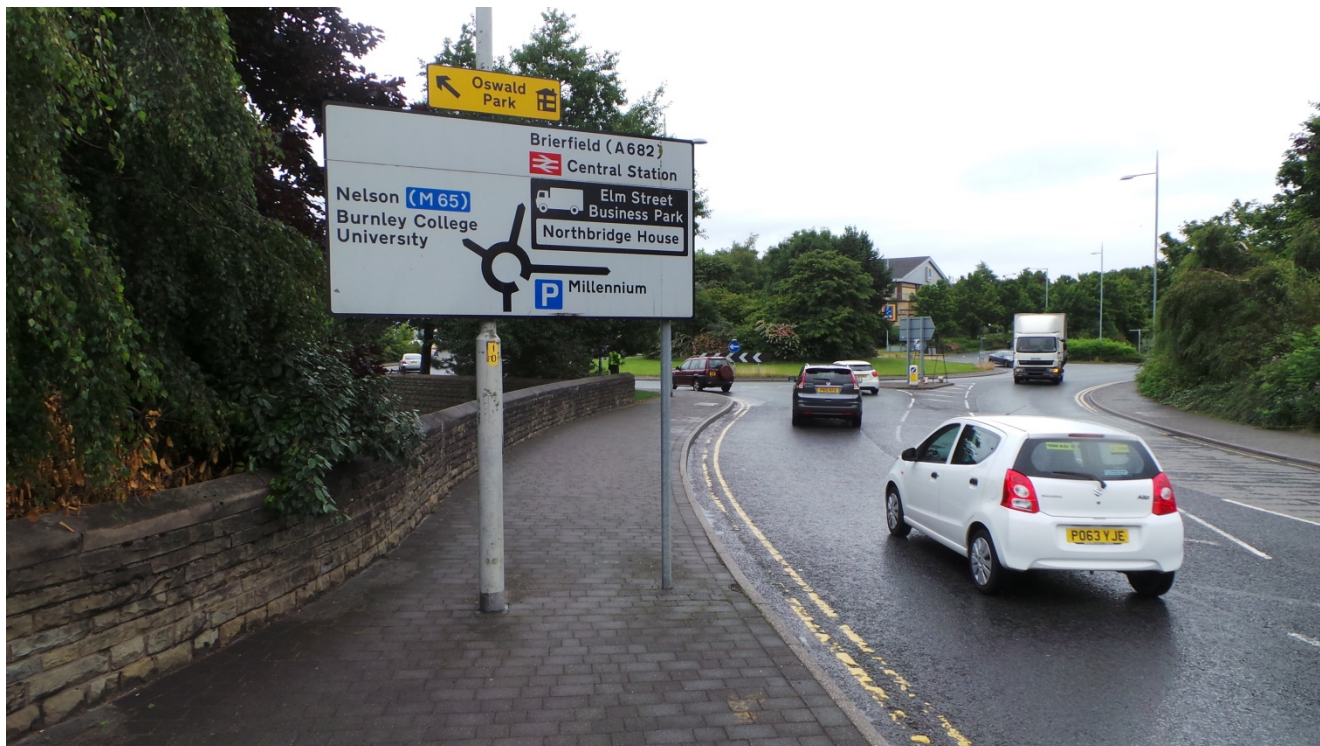
Figure A.1 : Existing Advance Direction sign (ADS) on the northbound approach to the roundabout, requiring mounting at 2.1m

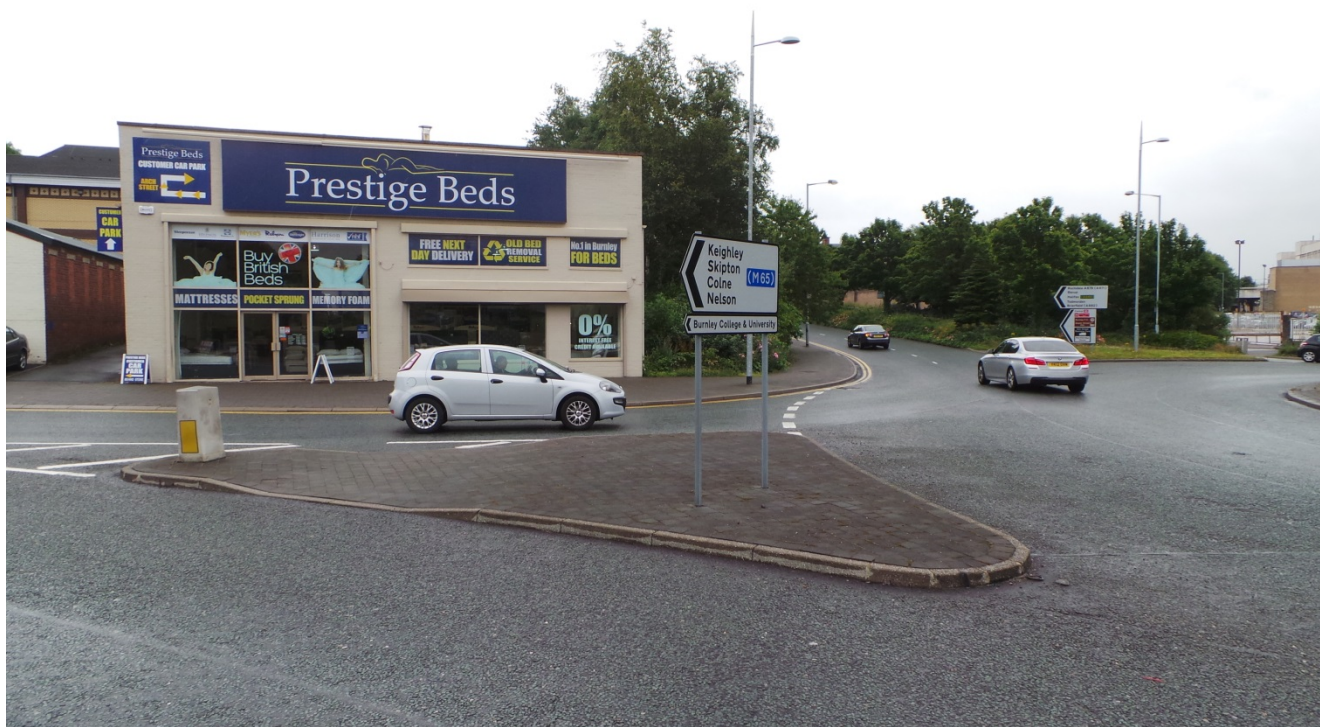
Figure A.2 : Existing flag type sign on Royle Road splitter island, requiring mounting at 2.1m

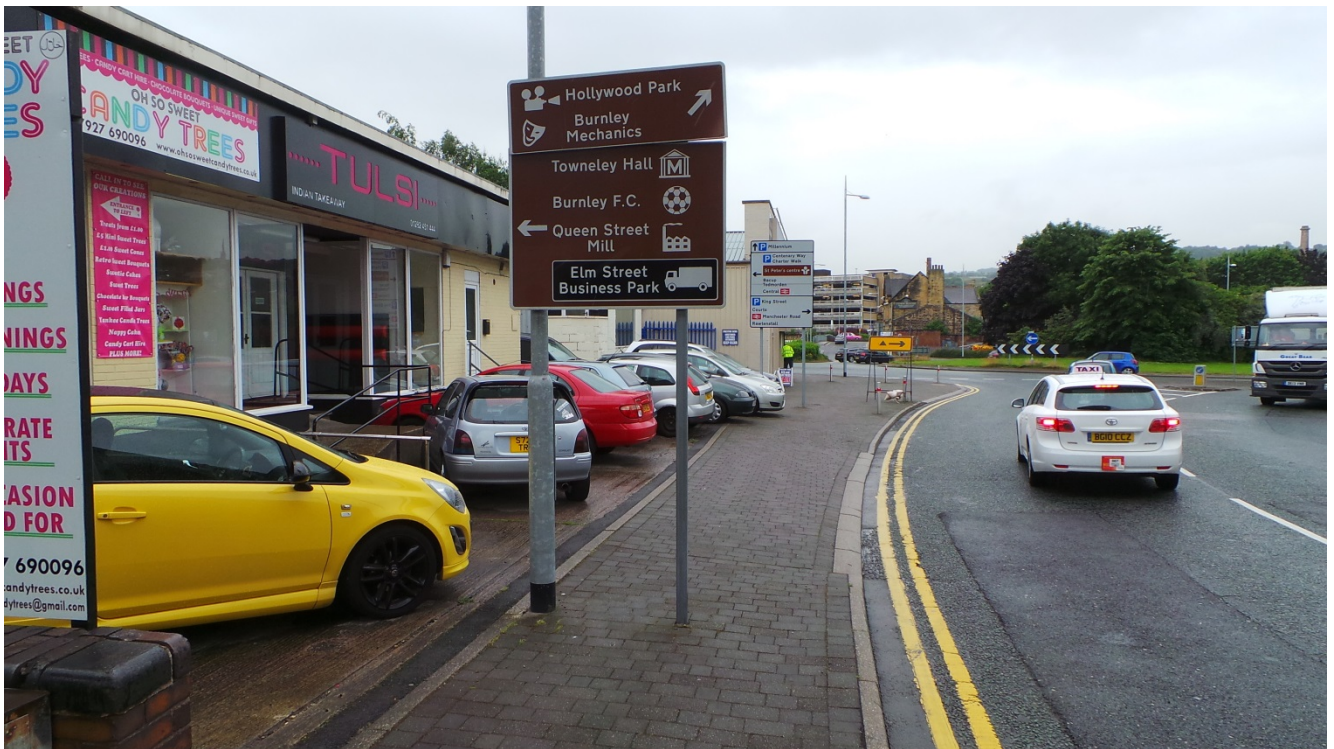
Figure A.3 : Existing Advance Direction sign (ADS) on the southbound approach to the roundabout, requiring mounting at 2.1m

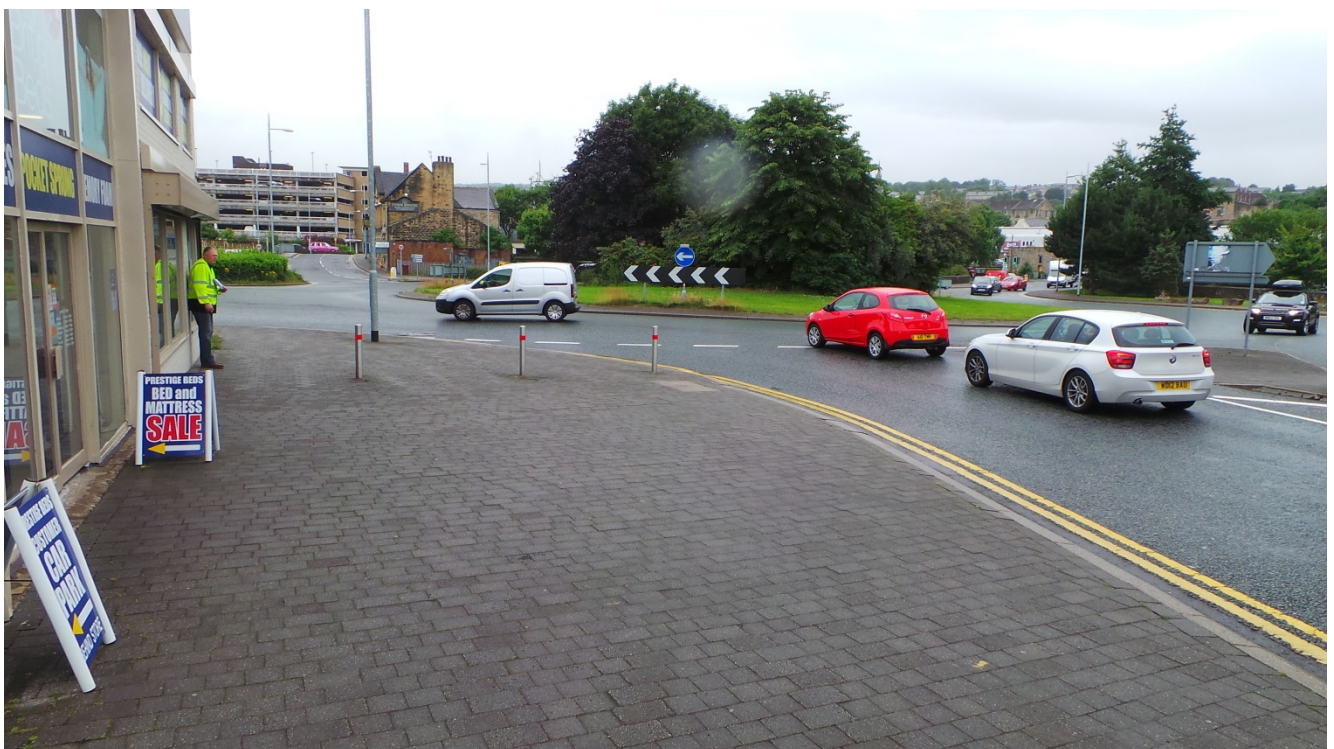
Figure A.4 : Area of footway surfacing and location of Toucan crossing across the southbound approach to the roundabout

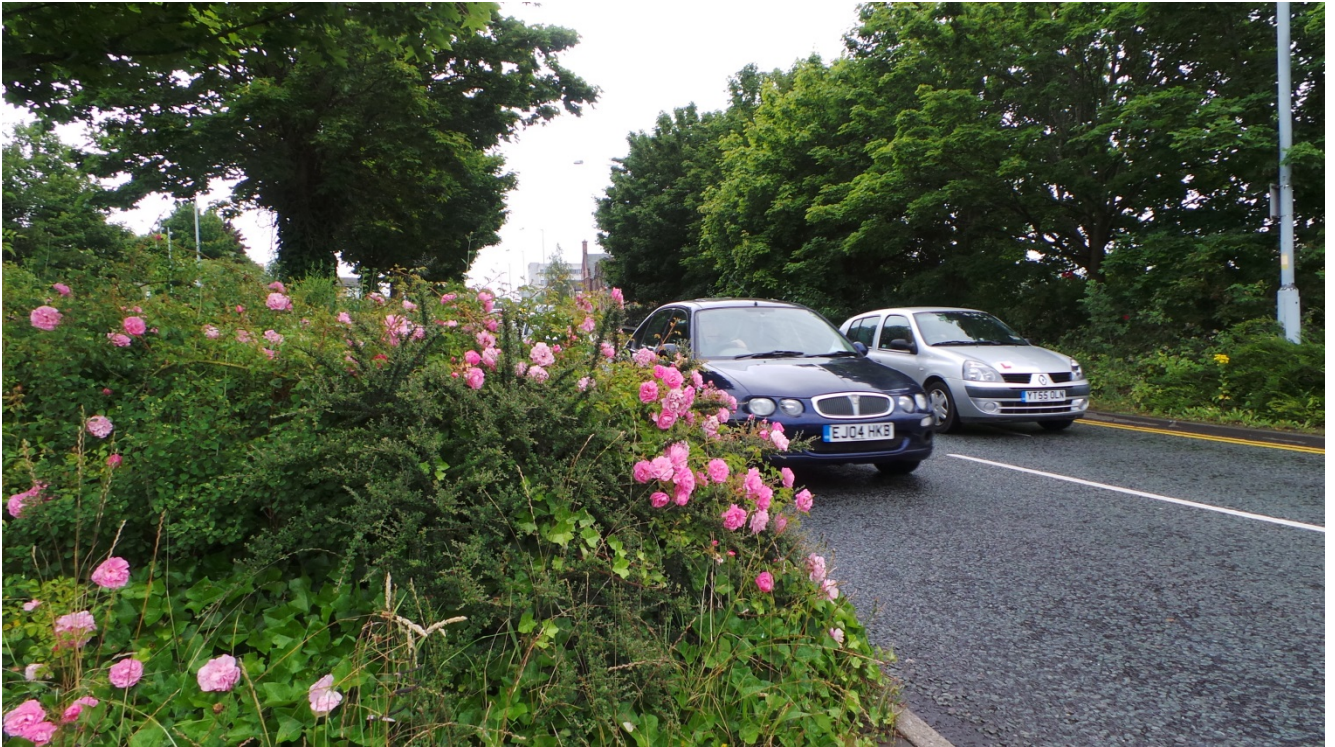
Figure A.5 : Looking left on Active Way, towards westbound traffic approaching the roundabout at the Toucan crossing location

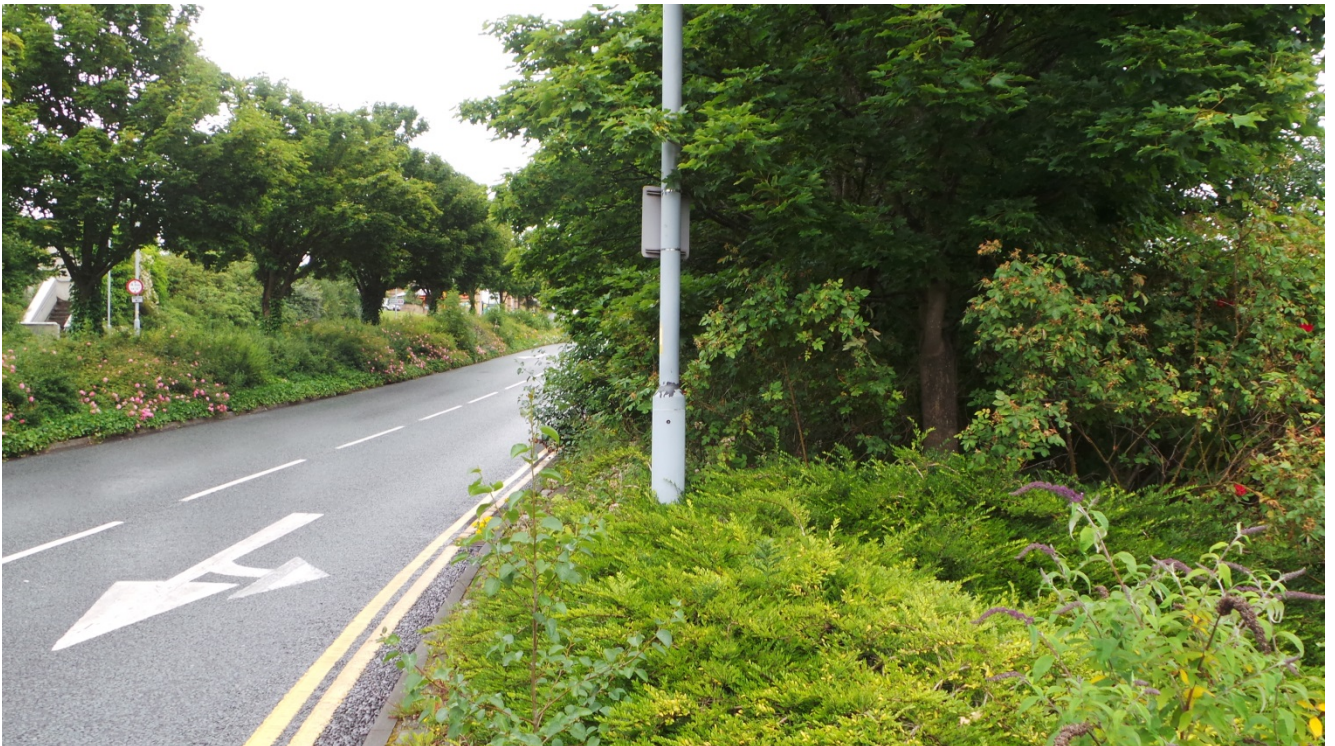
Figure A.6 : Looking right on Active Way, towards westbound traffic approaching the roundabout at the Toucan crossing location

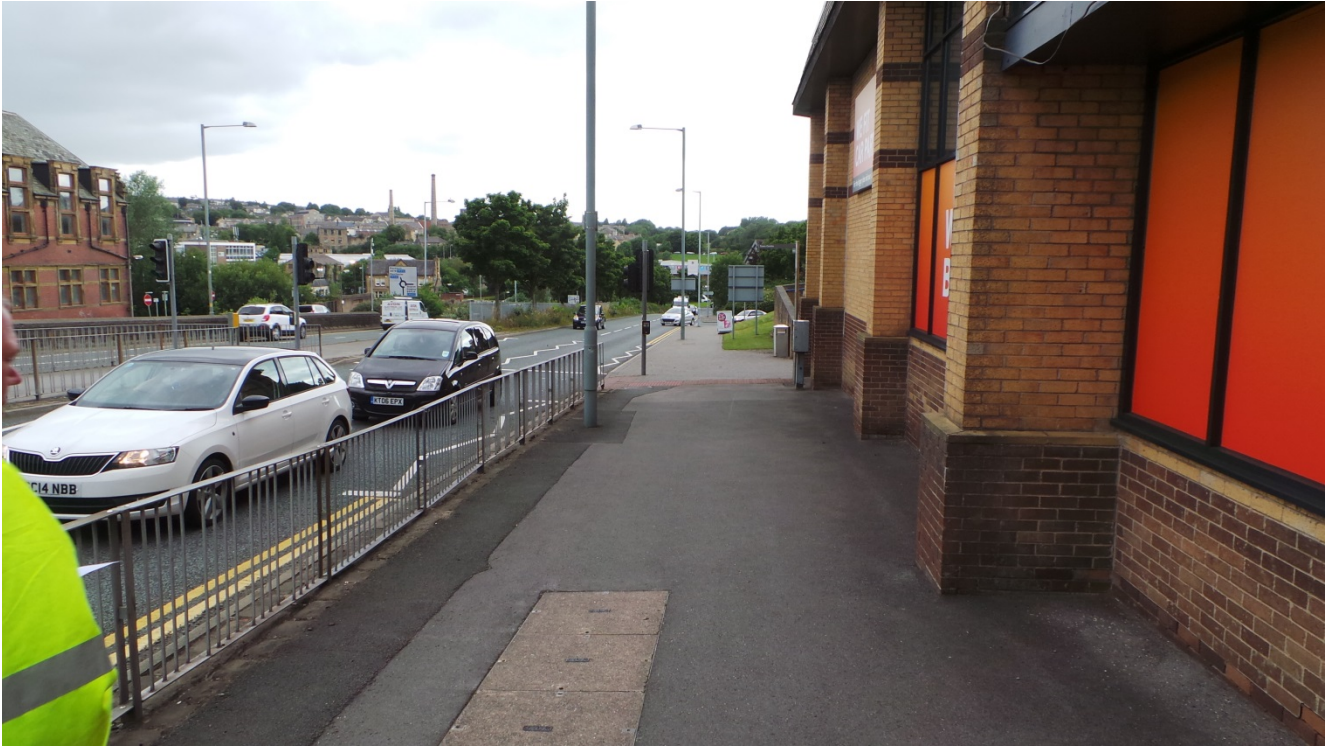
Figure A.1 : Looking west on the northern side of Active Way towards the proposed Toucan crossing

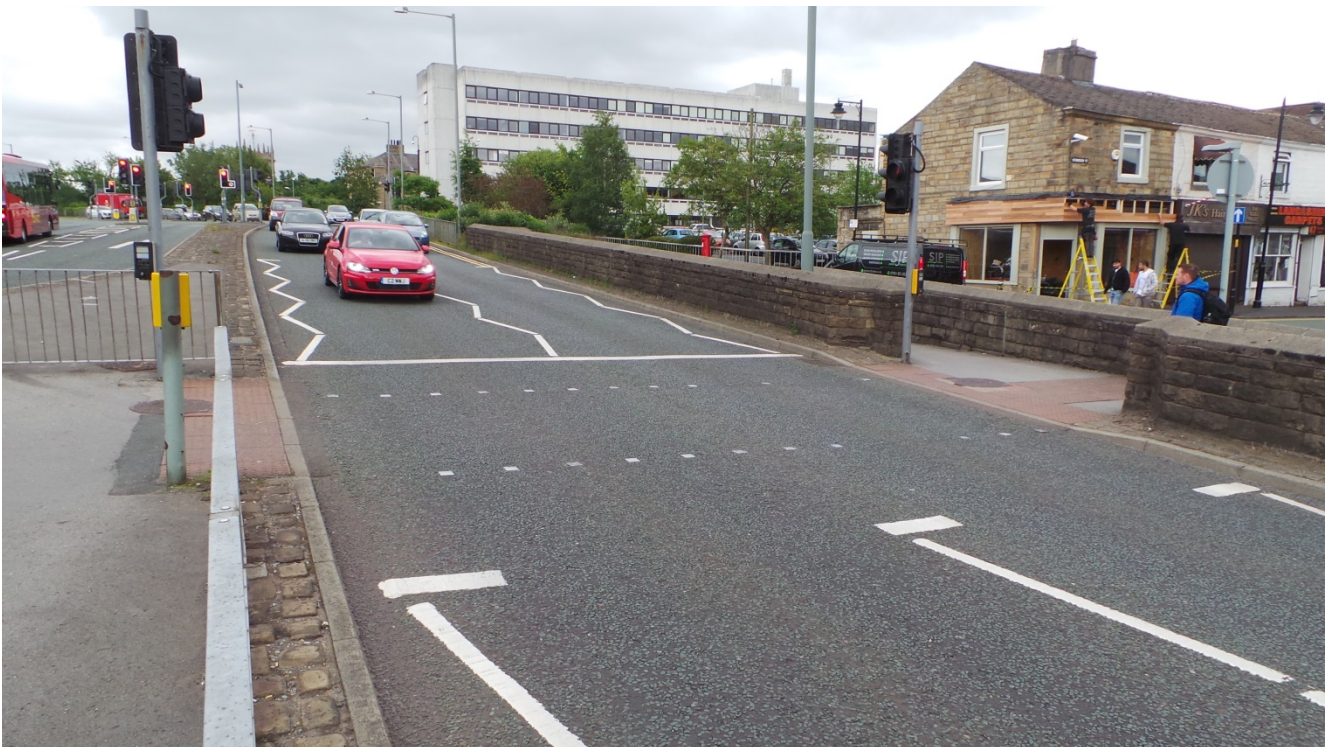
Figure A.2 : Looking east on active Way towards westbound traffic at the proposed Toucan crossing
