## Burnley Pendle Growth Corridor Junction K Church Street / Active Way

Stage 1 Road Safety Audit

CA307/ 1325|0

## Burnley Pendle Growth Corridor Junction L A670 Active Way / Westgate / Queens Lancashire Way / St. James's Street Crossroads

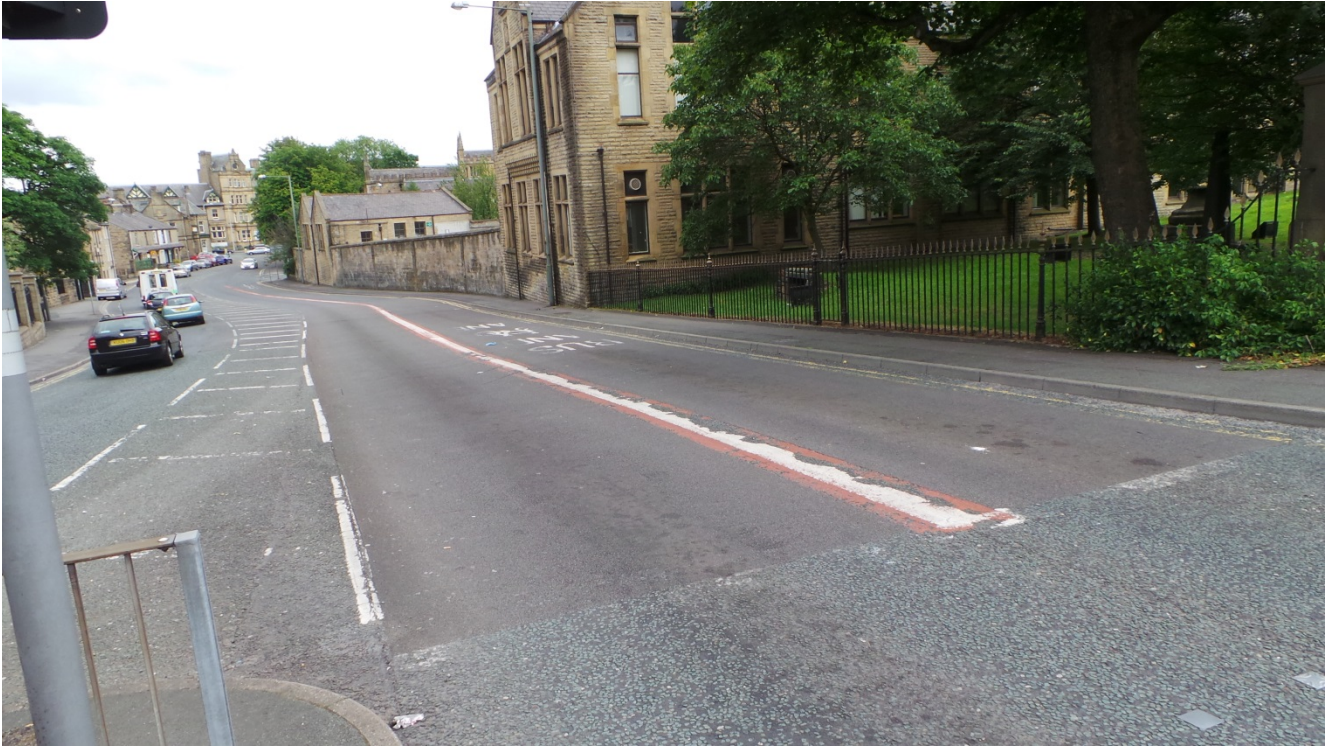
Figure A.1 : Looking southeast along Church Street

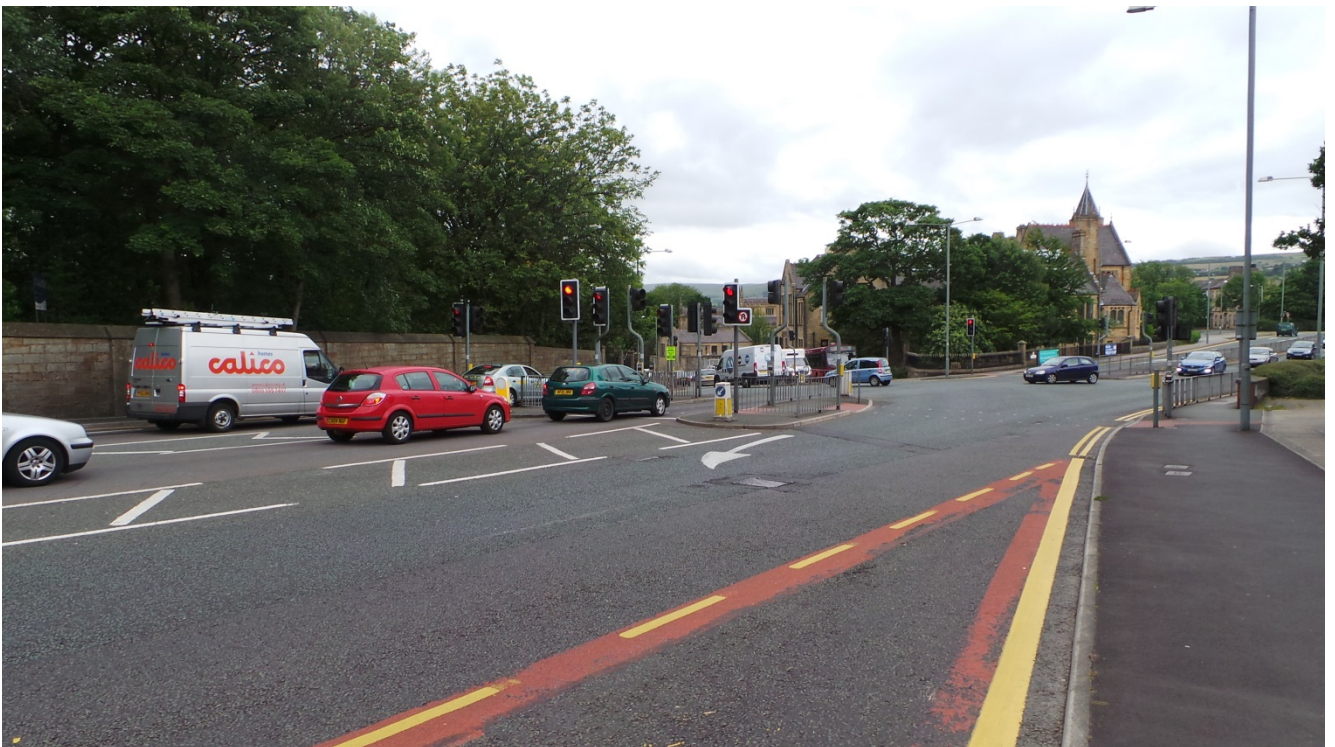
Figure A.2 : Looking south towards the junction from Active Way

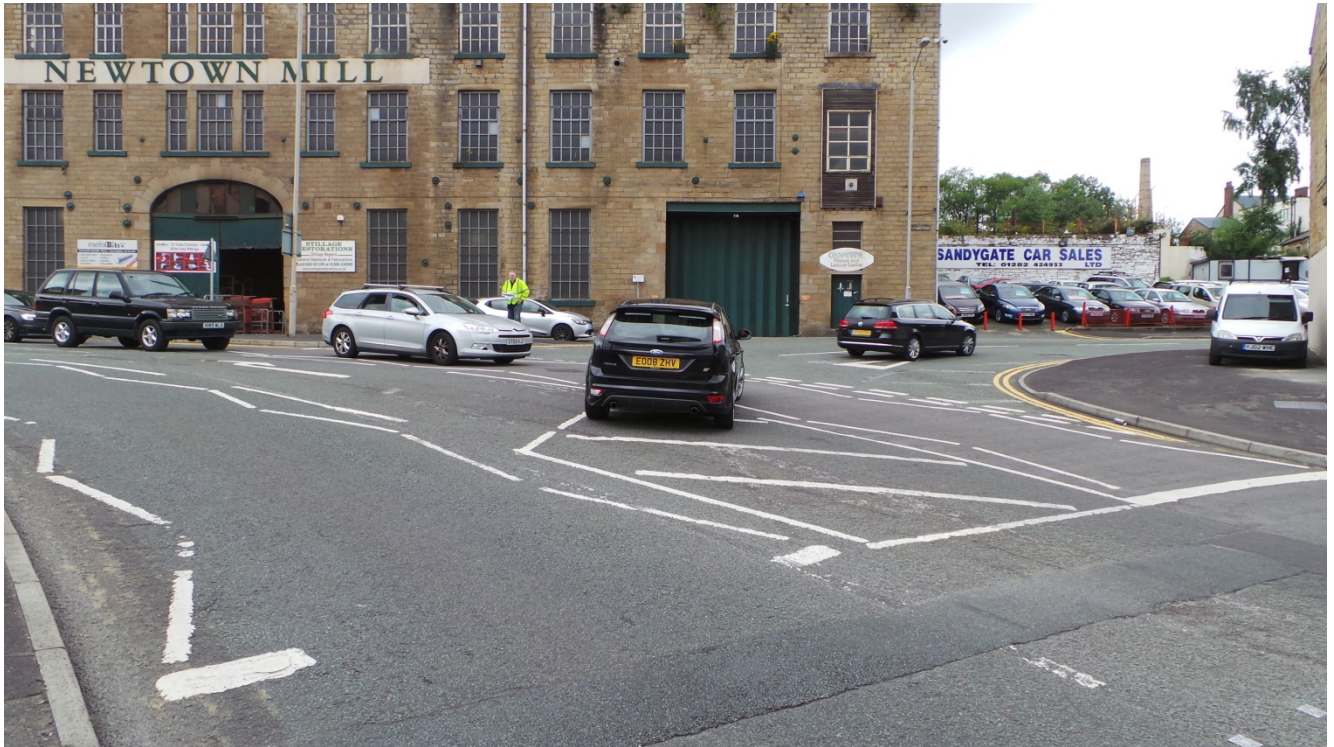
Figure A.1 : Vehicles turning right through gaps in waiting traffic into Sandygate.

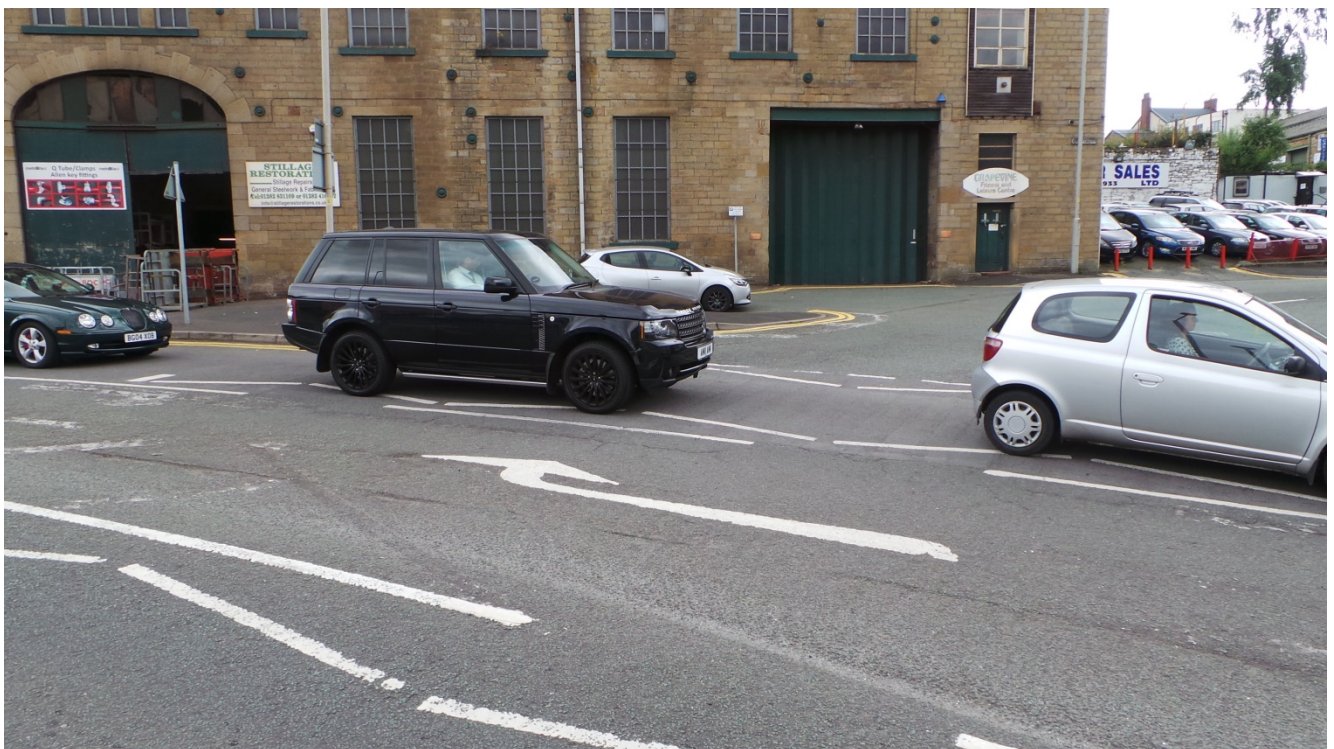
Vehicles were observed to queue on Queens Lancashire Way blocking the access to Sandygate for vehicles looking to turn right into or right out of Sandygate. This is due to vehicles waiting for pedestrians to cross the controlled crossing or by waiting at the give way of the roundabout. It is recommended that a yellow box marking is provided to ensure this area of the northbound lane is kept clear. (Refer to photo A.2).

Figure A.2 : Vehicles blocking access to Sandygate for westbound traffic, from Queen's Lancashire Way.

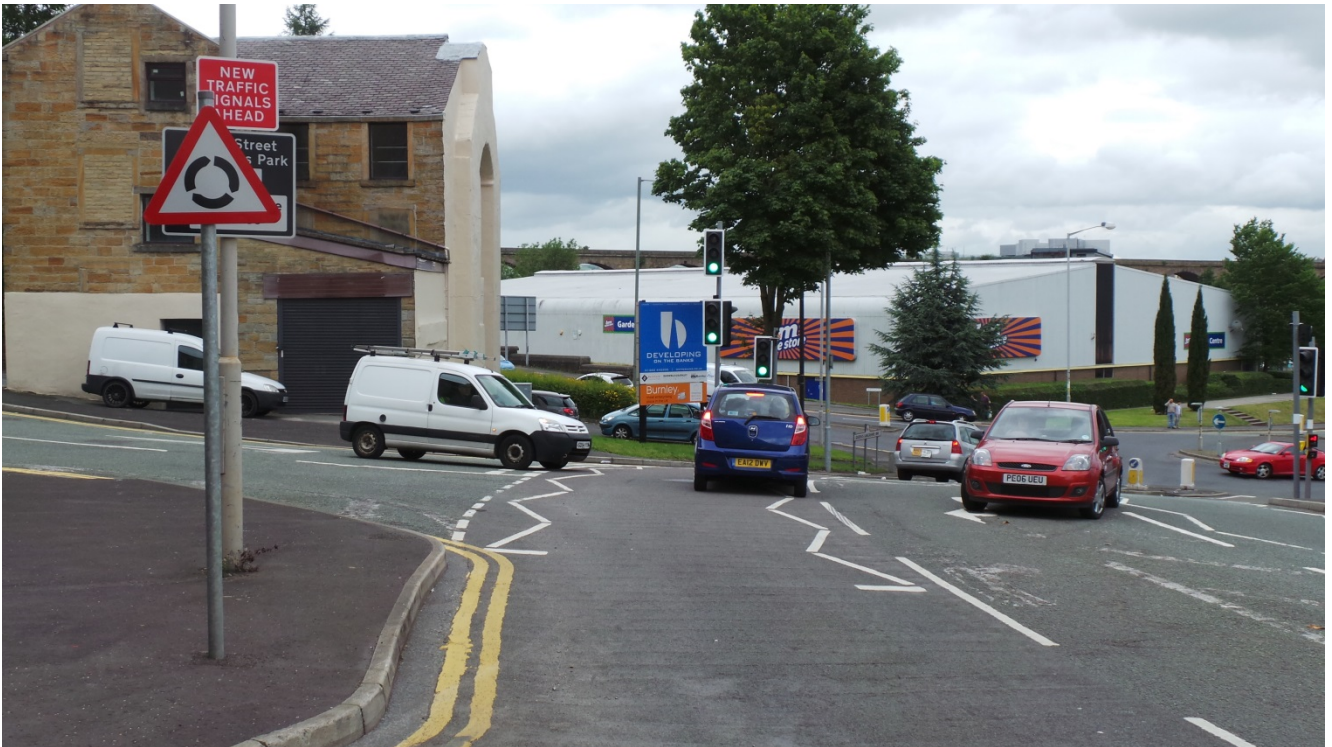
The existing roundabout warning sign on Queen's Lancashire Way which is located in advance of the Sandygate junction obscures the forward visibility to the 'HGV direction' and 'New Traffic Signals Ahead' sign, located on the adjacent lamp column (number 5). It is recommended that the location and mounting position of these signs is reviewed as part of the design process. (Refer to photo A.3).

Figure A.3 : Obscured signs including New Traffic Signals Ahead Sign

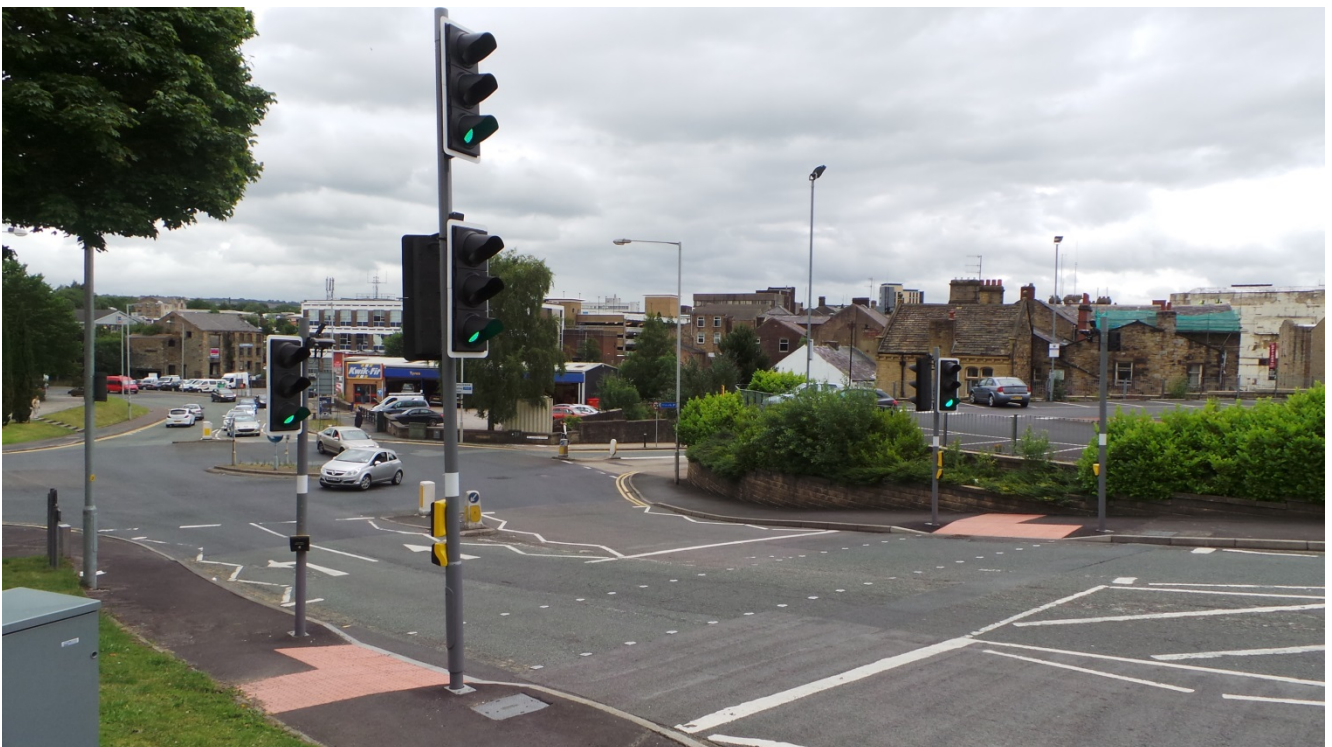
Figure A.4 : High level signal head may be obscured by tree canopy at new location

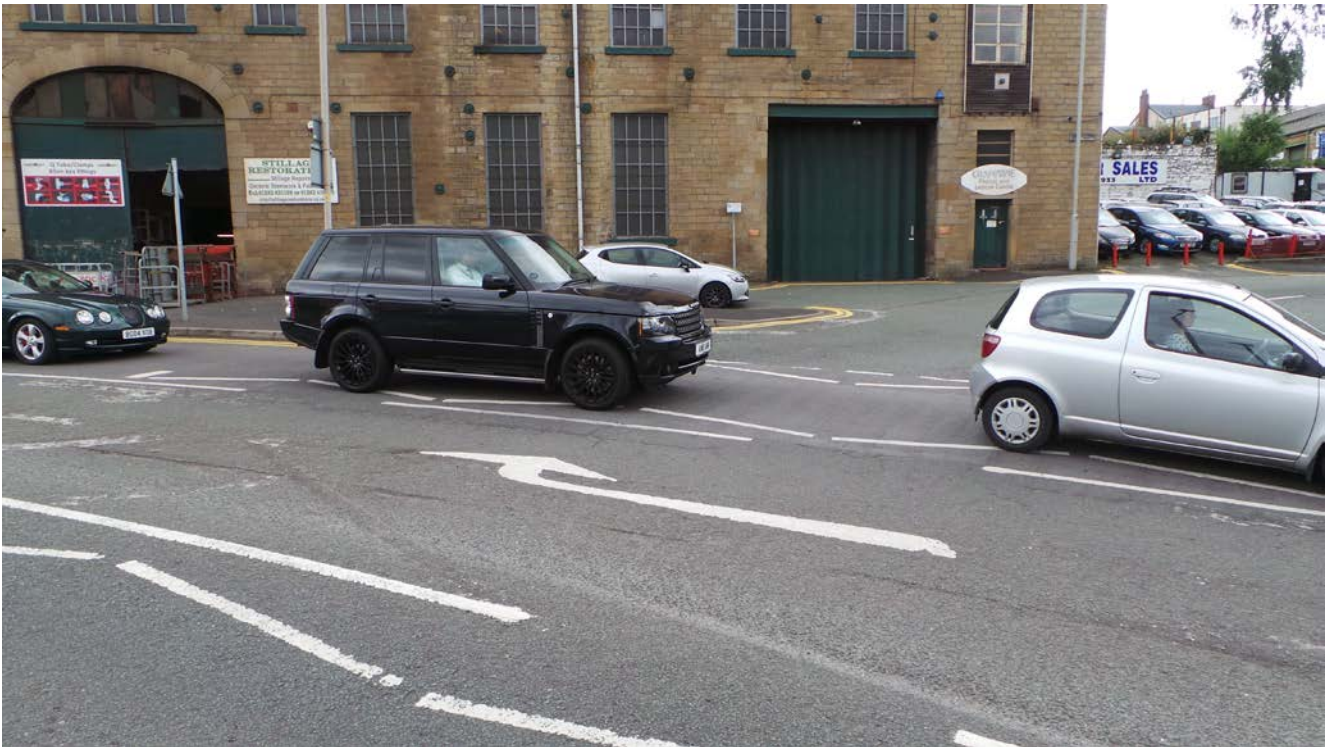
Figure A.5 : Vehicles queuing on Queens Lancashire Way block the entrance to Sandygate.

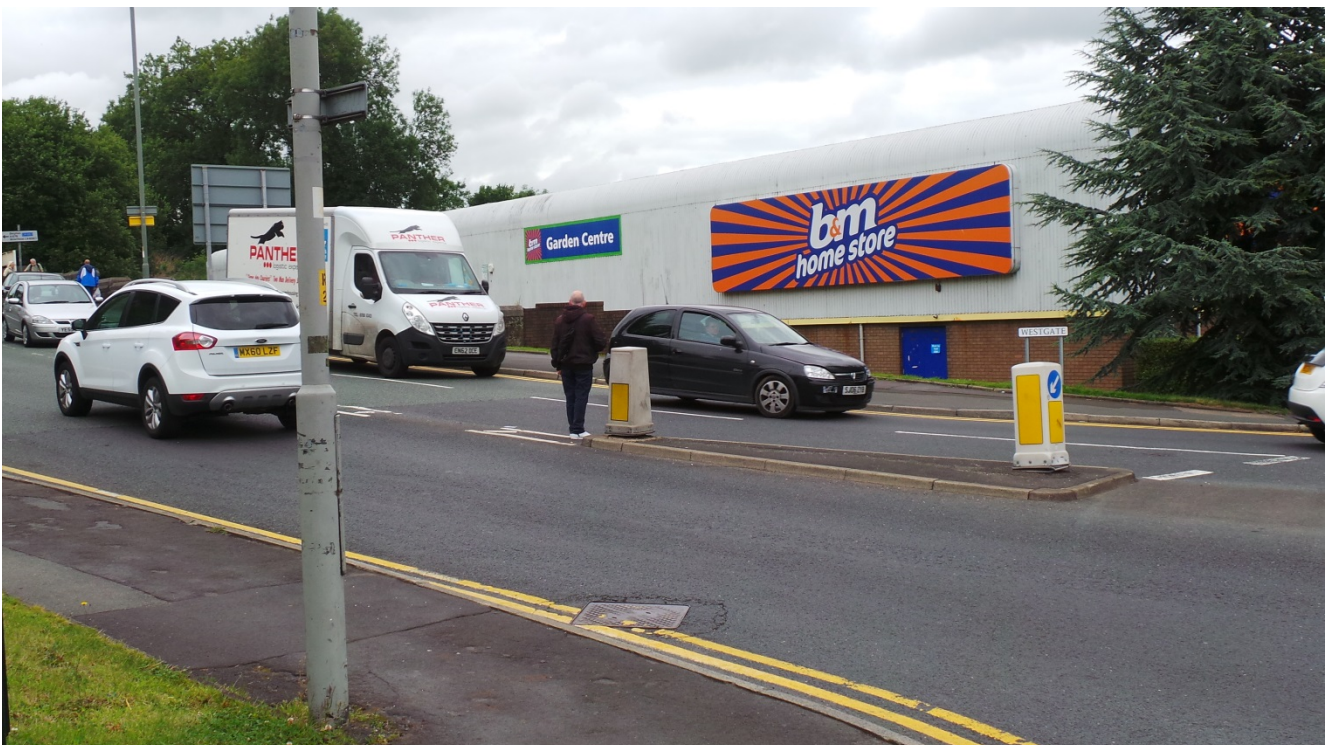
Concern was expressed that there is no pedestrian crossing facility on Westgate, in order to allow pedestrians travelling east on the southern footway, to cross the carriageway. Whilst on site, pedestrians were observed to be crossing at this location and standing in the road between opposing flows of oncoming traffic. (Refer to photo A.6),

Figure A.6 : Pedestrian observed crossing Westgate, where a crossing point is not proposed

It is recommended that a provision for pedestrians to cross Westgate is investigated and a traffic island is incorporated into the design to allow pedestrians to safely wait within the centre of the carriageway.

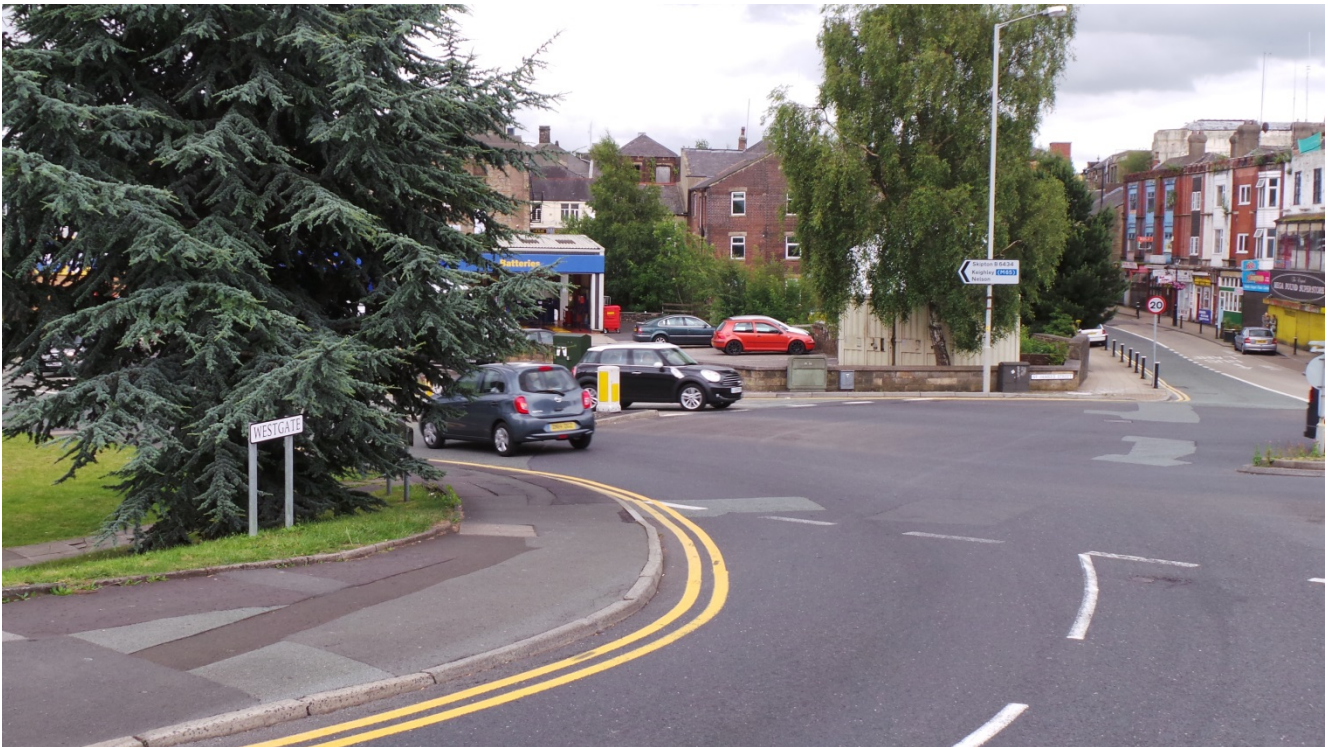
The tree located in the verge between Westgate and Active Way restricts the forward visibility to the crossing point on Active Way for vehicles travelling eastbound on Westgate. It is recommended that this tree is removed to ensure that the forward visibility is not compromised and to ensure that the available footway width is maintained for pedestrians. (Refer to photo A.7).

Figure A.7 : Limited forward visibility to the proposed crossing on Active Way from Westgate

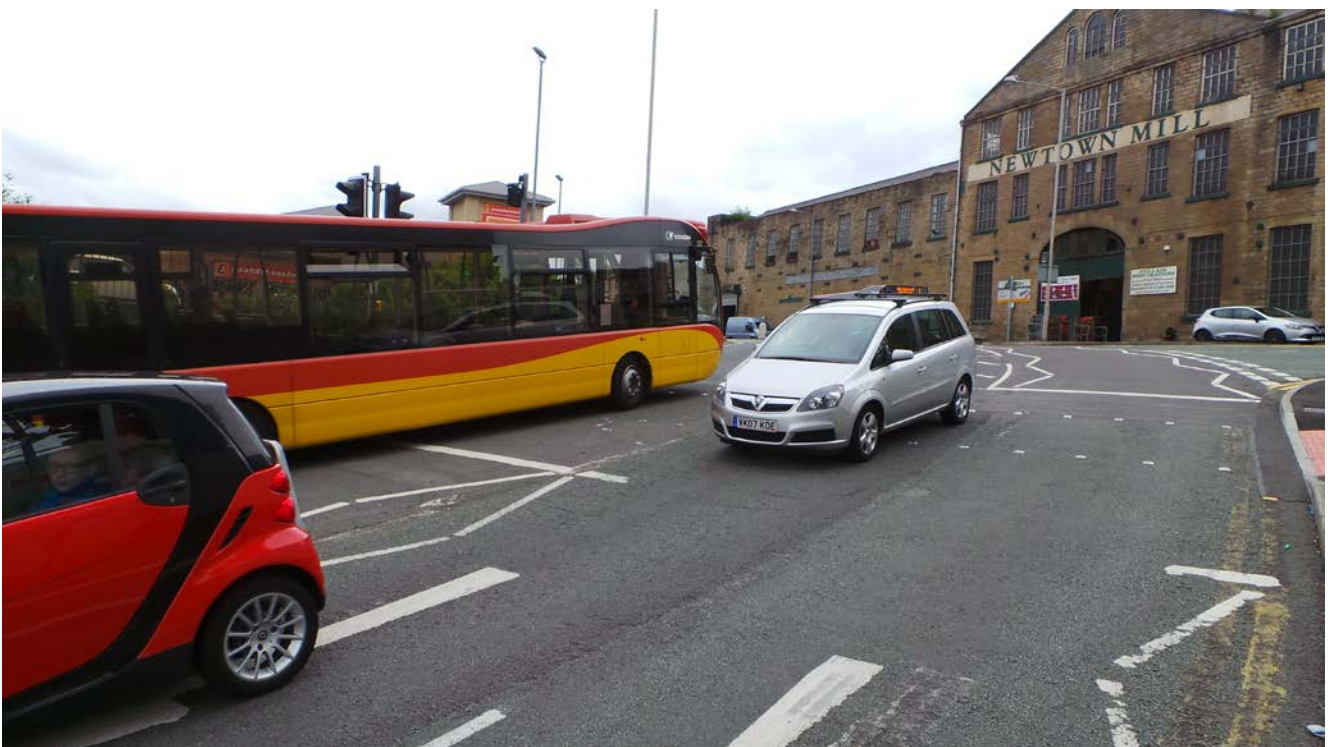
It was evidenced on site that buses when travelling south on Queens Lancashire Way they occasionally travel through the right turn lane for Sandgate. This may result in buses coming into conflict with the proposed pedestrian island, causing a collision.

Concern is expressed that lane encroachment could result in side swipe type collisions; also large vehicles may not be able to negotiate the new road layout, without coming into conflict or overrunning the new pedestrian crossings islands.

Figure A.8 : Buses overrun the right turn lane into Sandygate when travelling south on Queens Lancashire Way

It is recommended that it should be demonstrated using Autotrack templates that all vehicle types and manoeuvres are possible using the junction without lane encroachment.

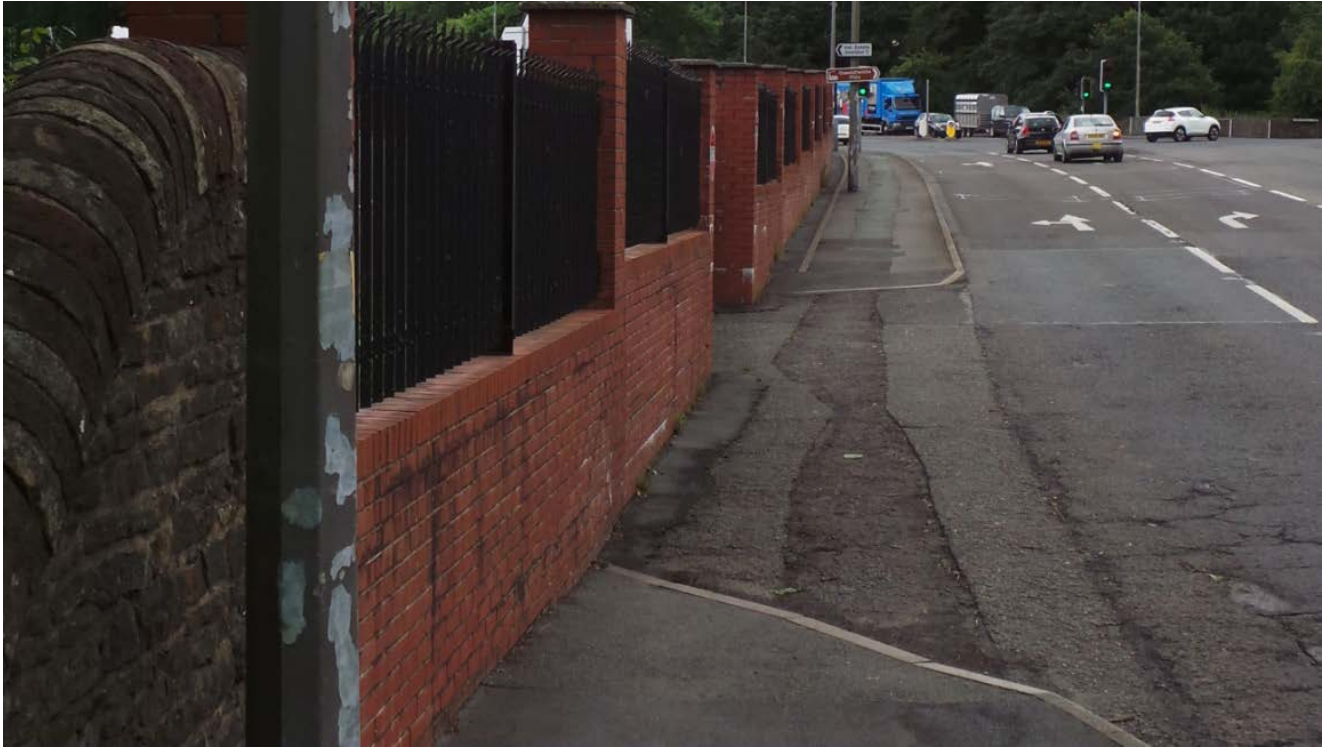
Figure A.1 : Existing access fronting the eastbound carriageway of Blackburn Road, showing required footway upgrade

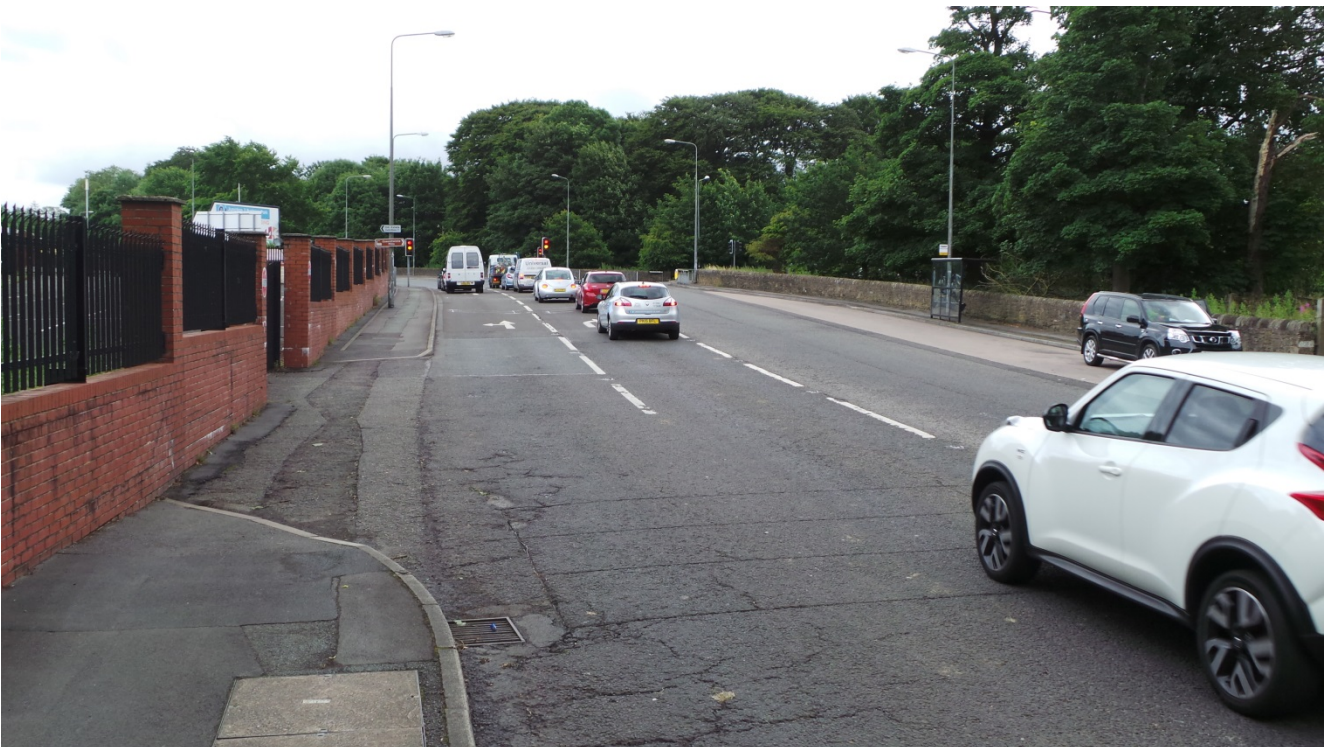
and tactile paving. Failure to provide adequate crossing facilities could result in pedestrians coming into conflict with vehicles causing serious injury. (Refer to photo A.2).

Figure A.2 : Eastbound approach to the junction on Blackburn Road

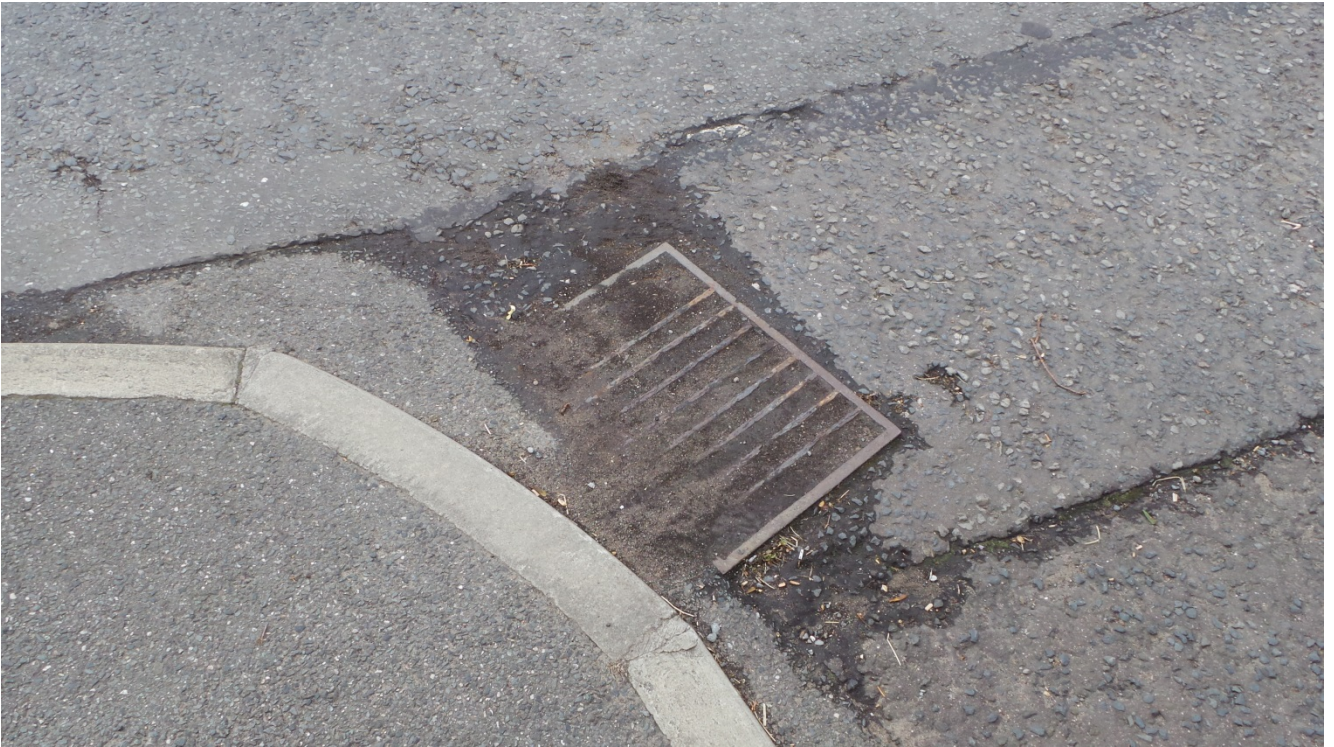
It was observed on site that a number of gullies were blocked. This poses a hazard during periods of rain or during freezing conditions as the carriageway surface will not drain sufficiently. (Refer to photo A.3).

Figure A.3 : Blocked gully in the channel of Blackburn Road, located on the eastbound approach to the junction

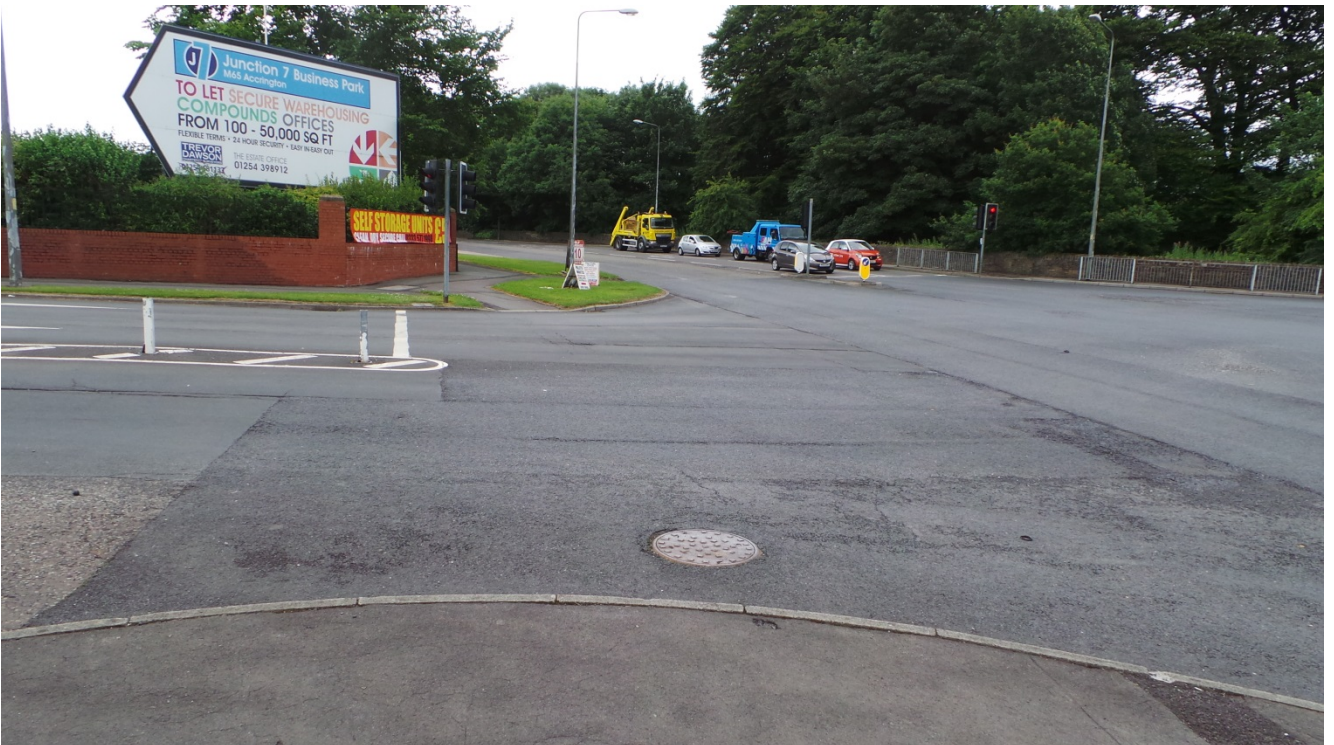
Concern is expressed that it is unclear from the drawing as to the level of detail proposed to upgrade the pedestrian facilities at the junction. Inadequate pedestrian crossing facilities could result in pedestrians coming into conflict with motorists resulting in serious injury. (Refer to photo A.4).

Figure A.4 : Highway metal work in line with proposed crossing of the Junction 7 industrial estate

It is recommended that during the detailed design stage; the provision of tactile paving is aligned to lead pedestrians across the arm of each junction to either a refuge or the adjacent footway and a gap in the guard railing provided. It is also recommended that any existing ironwork or drainage in the carriageway does not conflict with these paths, thereby reducing the risk of slips, trips or falls. (Refer to photo A.4).

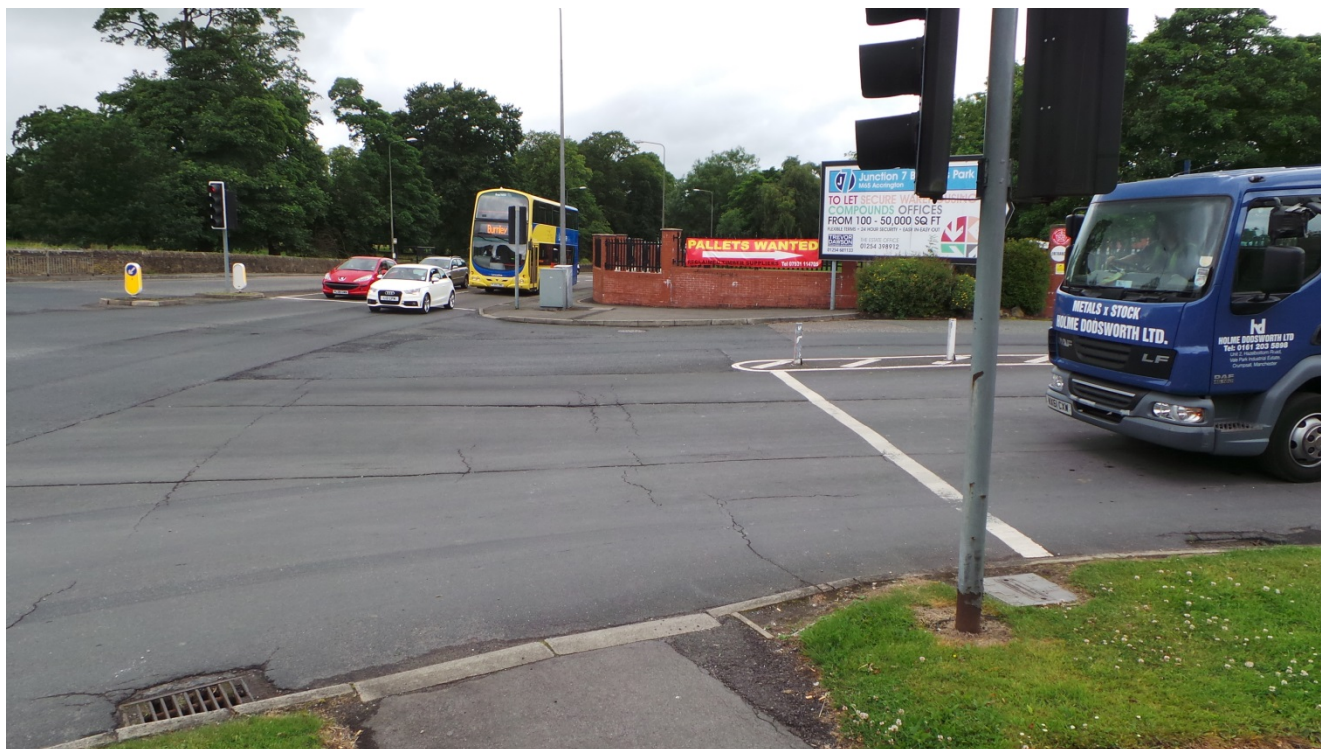
Figure A.5 : Existing footway directing pedestrians into junction and not across estate access

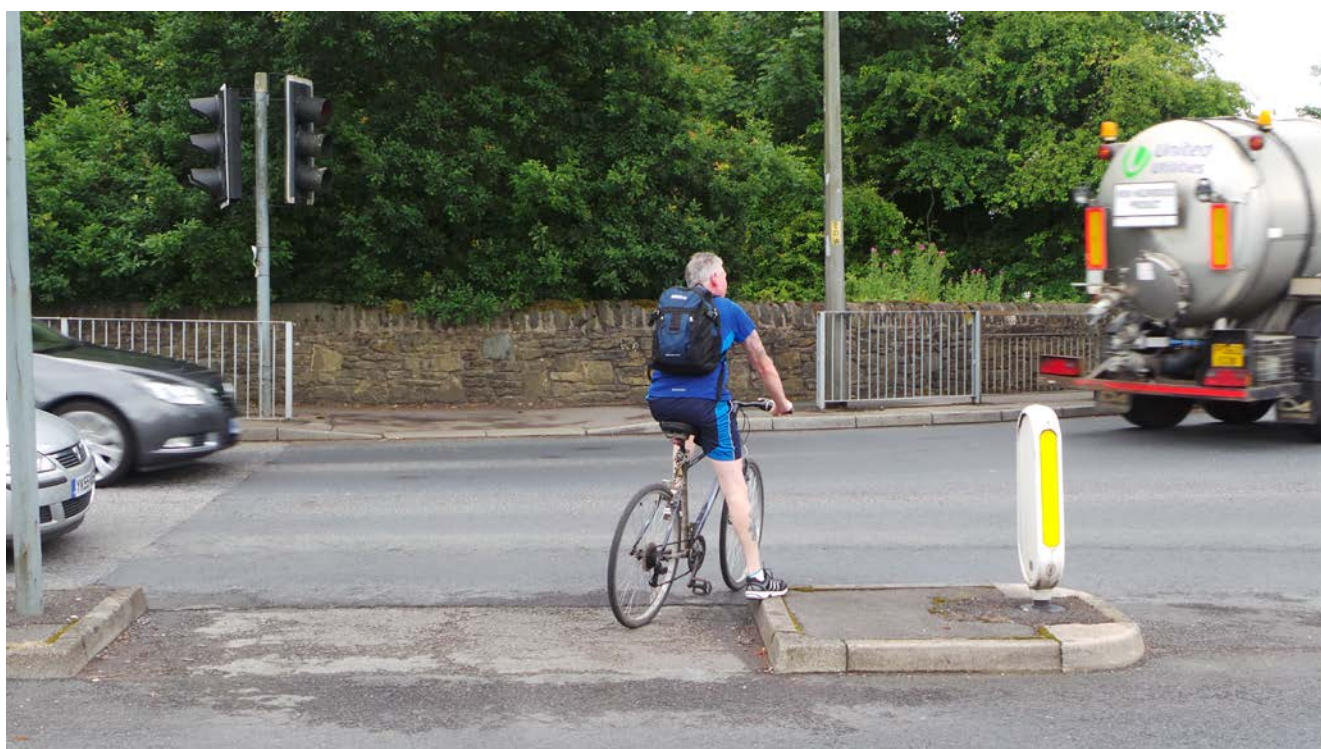
Figure A.6 : Existing traffic island on Blackburn Road, on the eastern arm of the junction

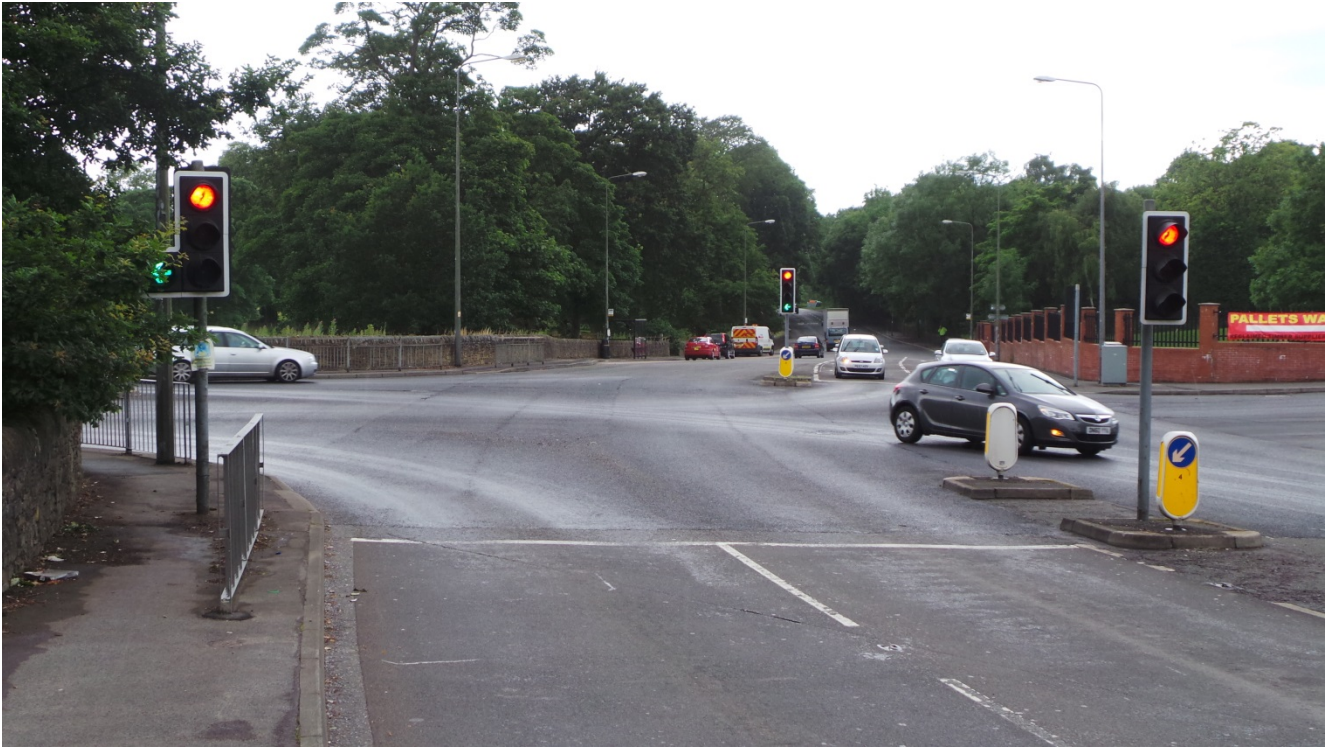
Figure A.7 : Vegetation obscuring the westbound signal head at the junction

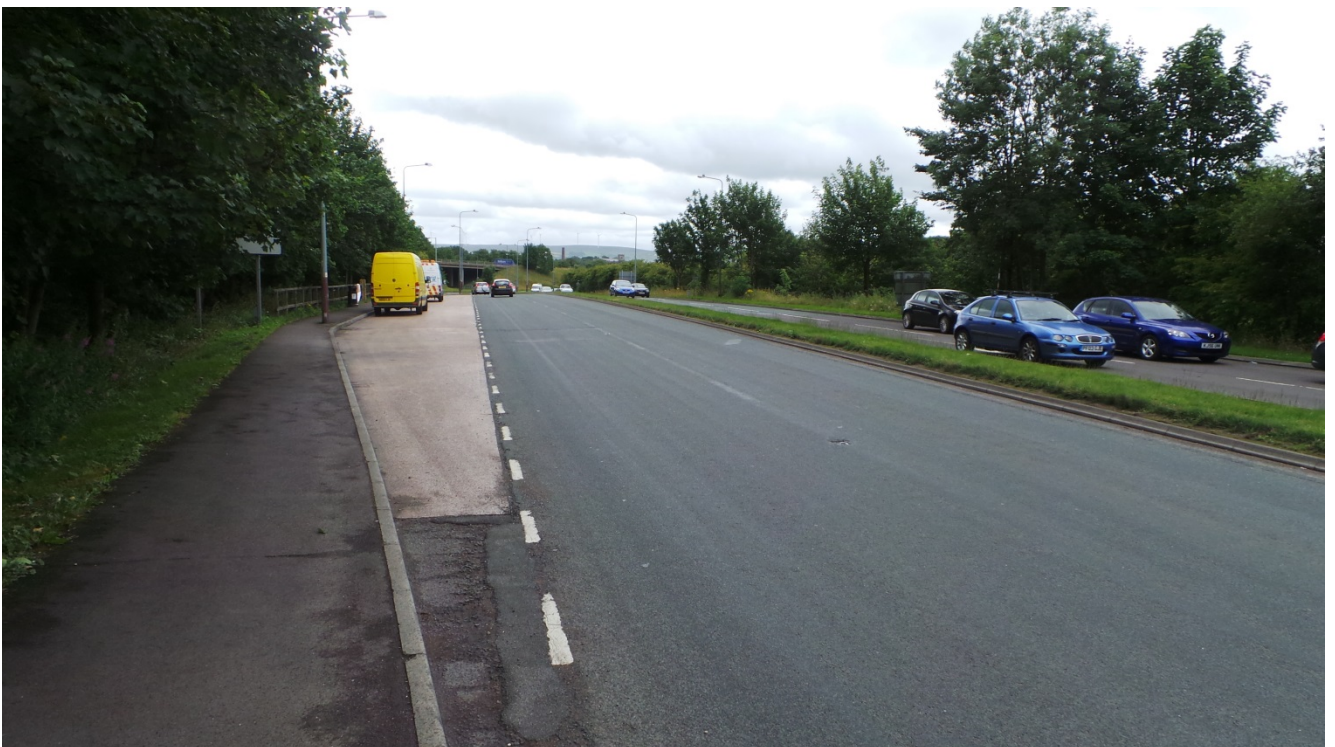
Figure A.8 : Vegetation obscuring the southbound Advance Direction Sign (ADS) on Dunkenhagh Way

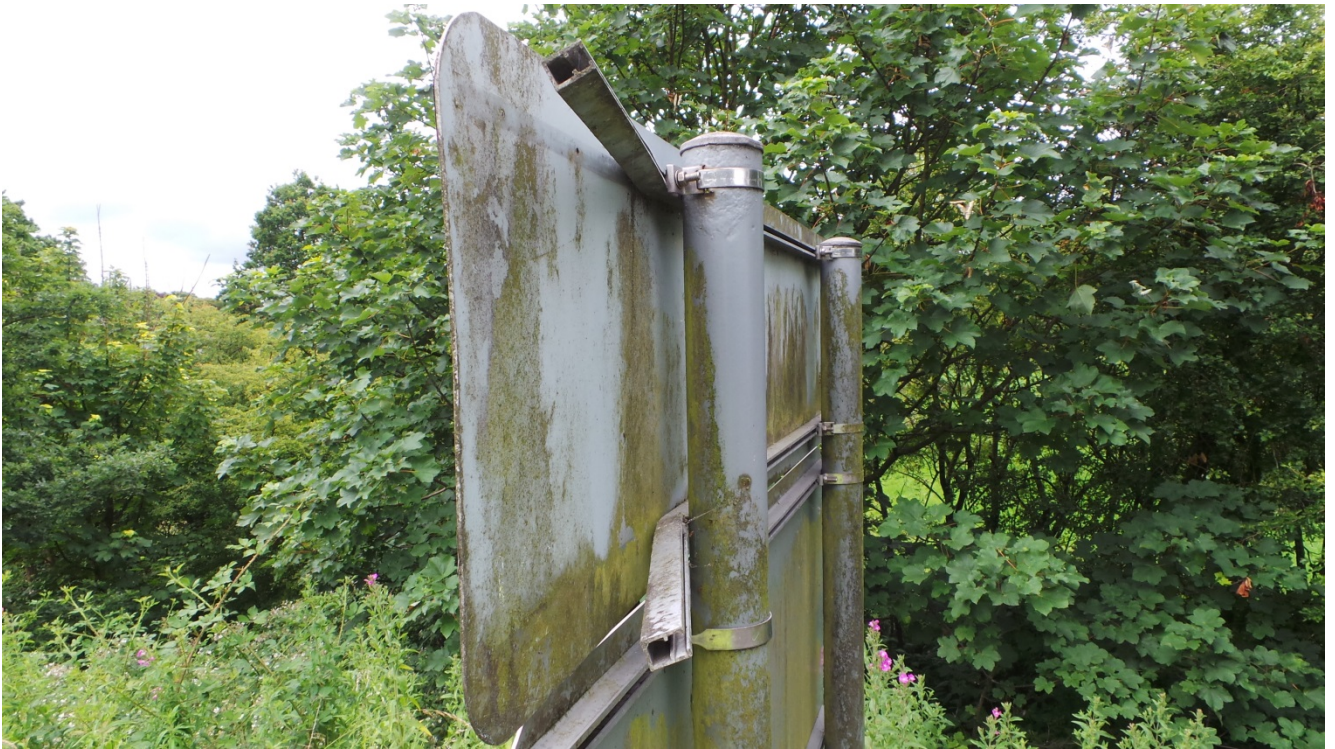
Figure A.9 : Damaged stack type sign on Dunkenhalth Way, on the northbound approach to the junction

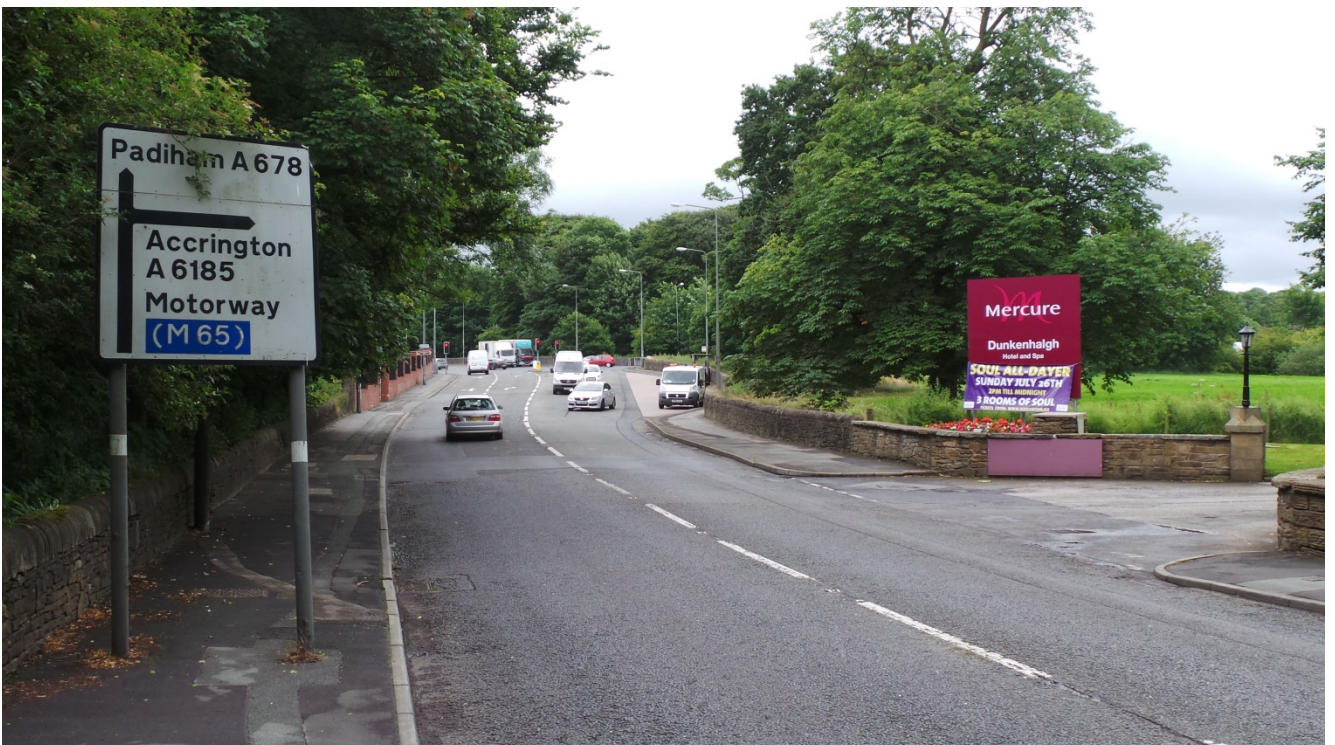
Figure A.10 : Blackburn Road, eastbound approach to the junction
