Burnley Pendle Growth Corridor Junction P Dunkenhalgh Way / Petre Road Junction

Lancashire County Council

Stage 1 Road Safety Audit

7 August 2015

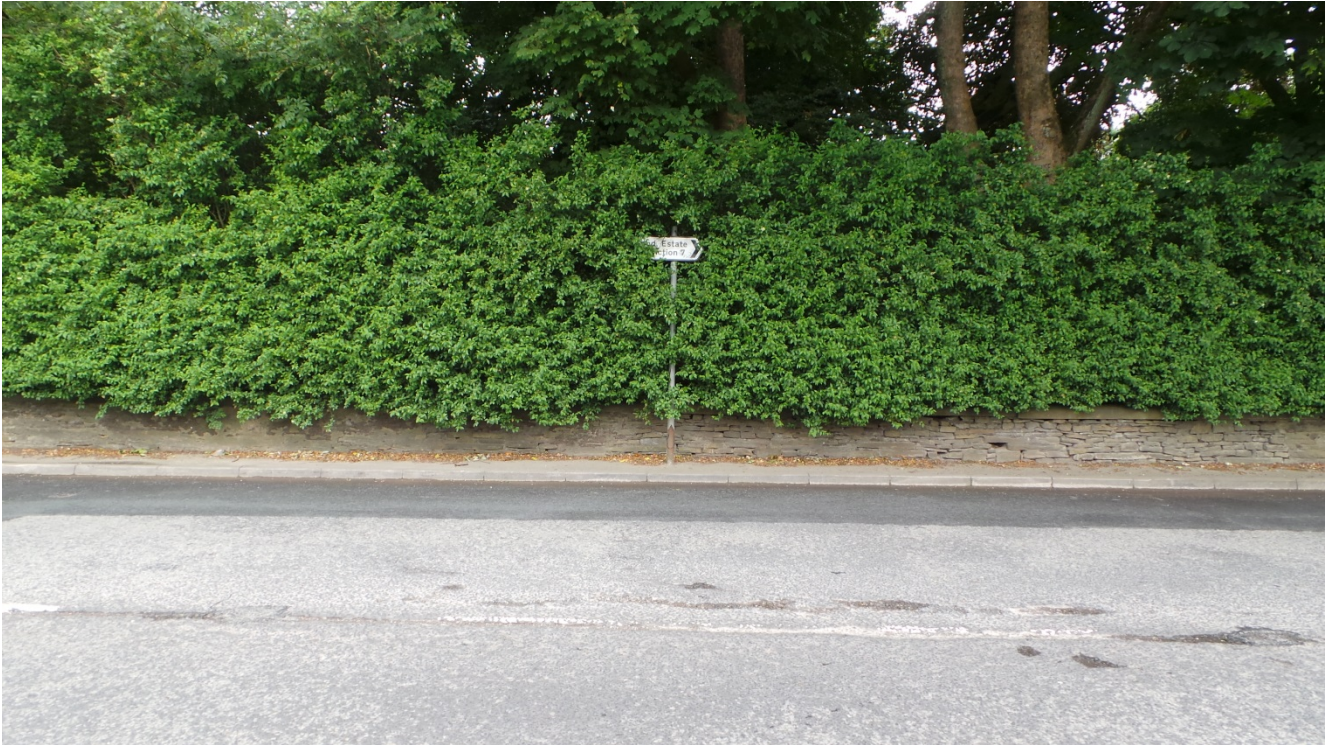
Figure A.1 : Flag sign opposite Petre Road, obscured by vegetation

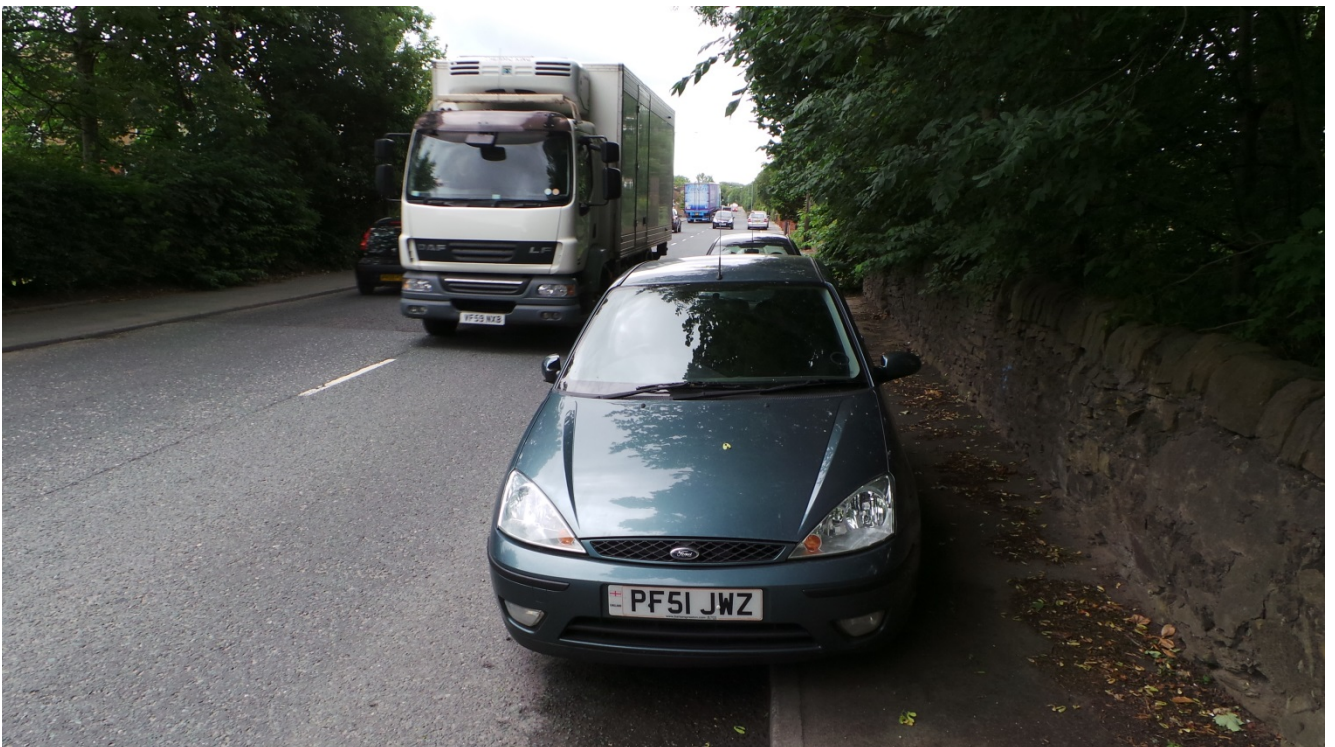
It was observed that visitors to the business park off Petre Road, parked on Blackburn Road Blackburn Road on the westbound side of the road opposite house number 156. Should vehicles continue to park there in the future they may affect the flow of traffic approaching the junction and become a hazard when passed by westbound vehicles. (Refer to photo A.2).

Figure A.2 : On street parking on Blackburn Road, on westbound approach to Petre junction

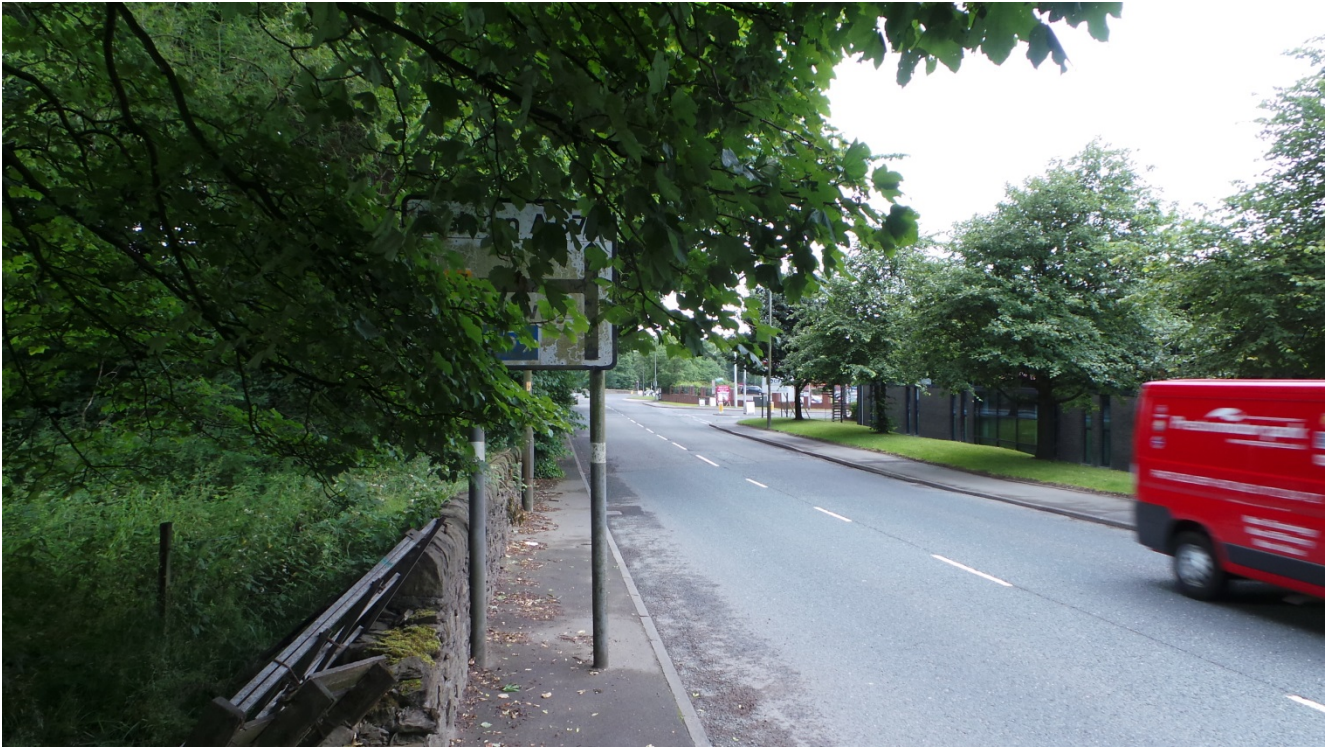
The Advance Direction Sign (ADS) for the Blackburn Road / Dunkenhagh crossroads is obscured by trees, which have also discoloured the sign. The vegetation requires cutting back in advance of the sign and a review of the sign layout undertaken to ensure that it reflects the layout of the junction ahead.

Figure A.3 : Advance Direction Sign on westbound approach to the junction obscured by adjacent trees

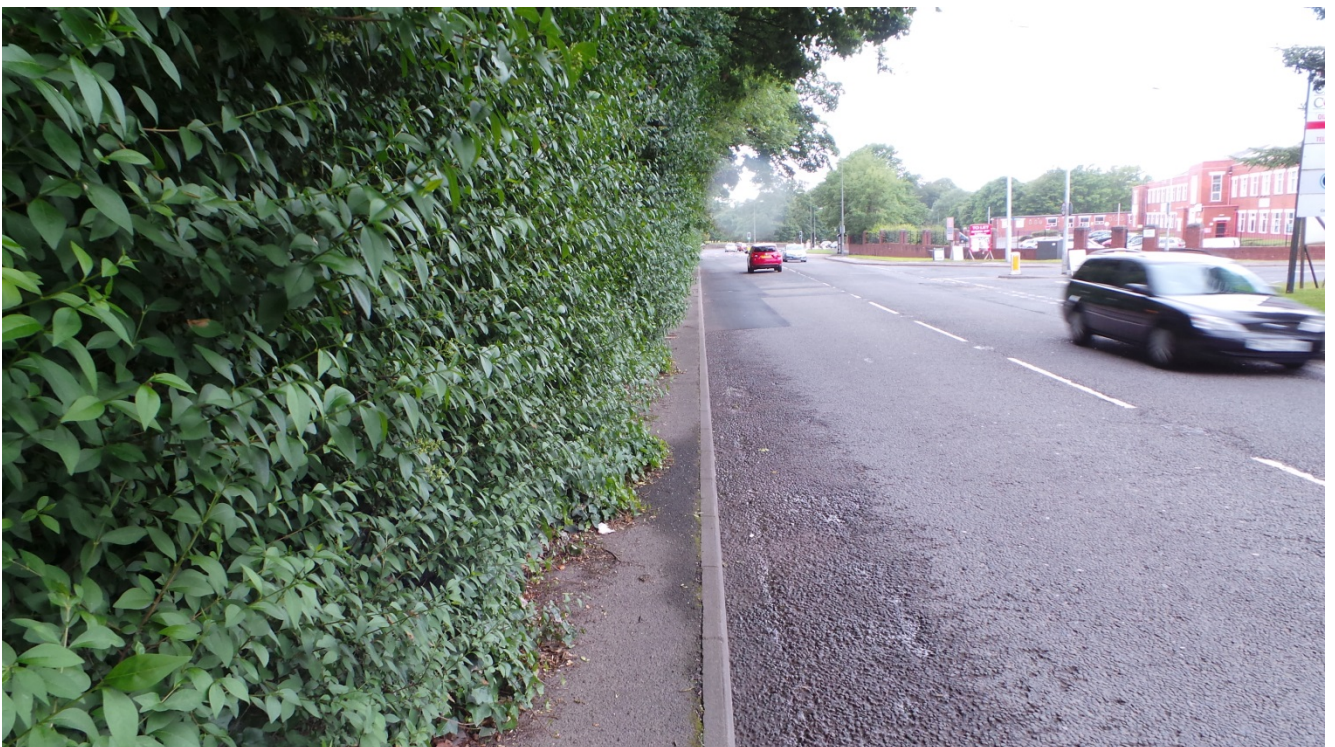
The footway which runs along the south side of Blackburn Road is overgrown by vegetation from the adjacent property and requires cutting back, in order to be able to be used by pedestrians. In addition, the flag type sign opposite Petre Road is hidden within this vegetation from the adjacent property and is difficult to clearly read. This vegetation should be cut back.

Figure A.4 : Vegetation overgrowing the footway to the south of Blackburn Road

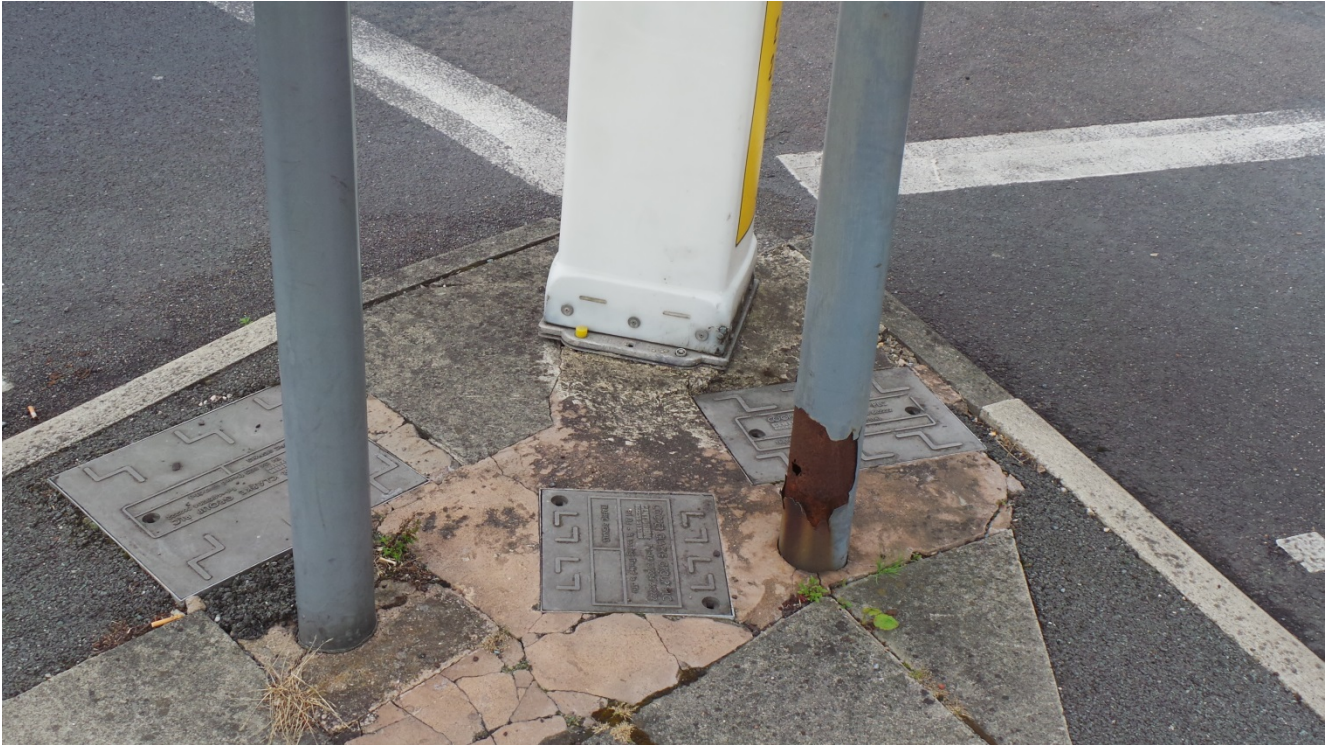
It is observed that the existing crossing infrastructure on site is in poor condition and it has been assumed signal poles, signal equipment, tactiles and guard railing will be replaced as part of the proposed works.

Figure A.1 : Evidence of corrosion to signal infrastructure

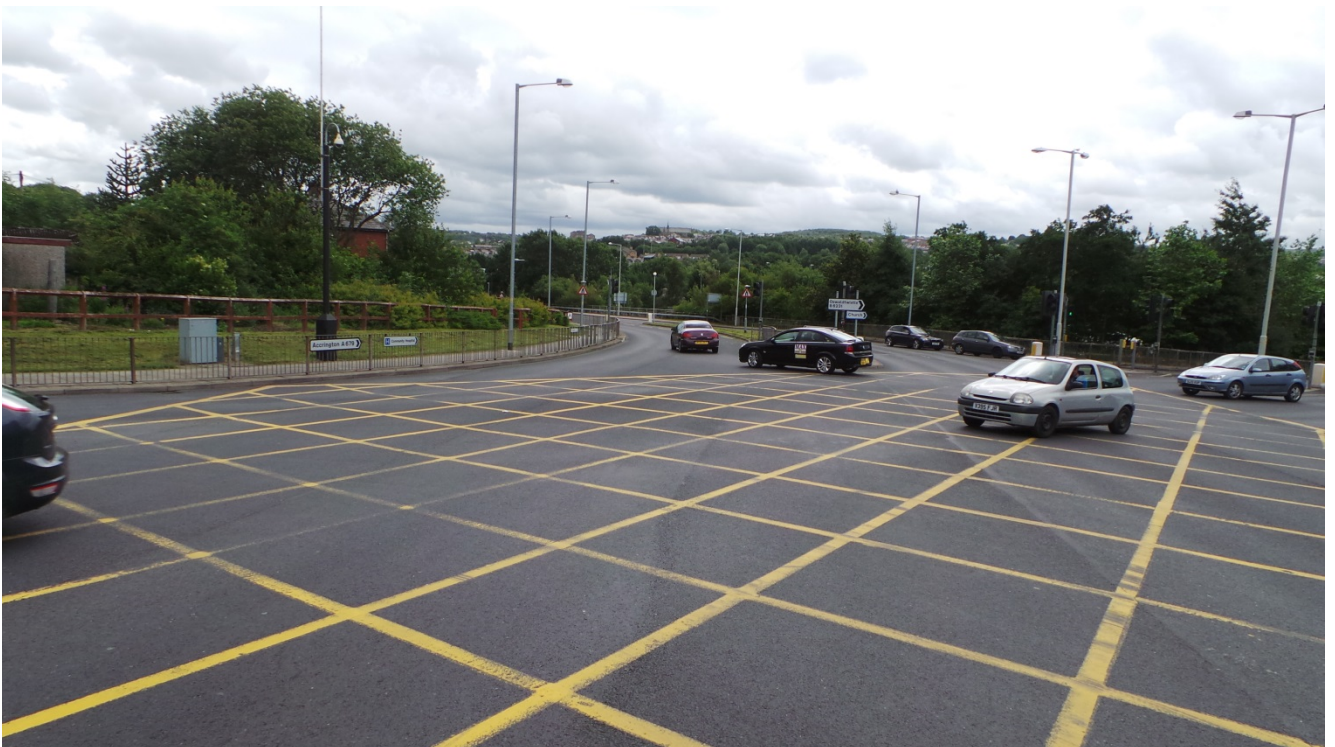
It is noted that there is no proposal to provide the yellow box marking that is currently found on site, it was observed during the site visit that the junction currently suffers from congestion, it is considered that the removal of the yellow box marking will lead to vehicles waiting in the centre of the junction causing further congestion on all arms of the junction.

Figure A.2 : Yellow box marking covering the extents of the junction crossroads

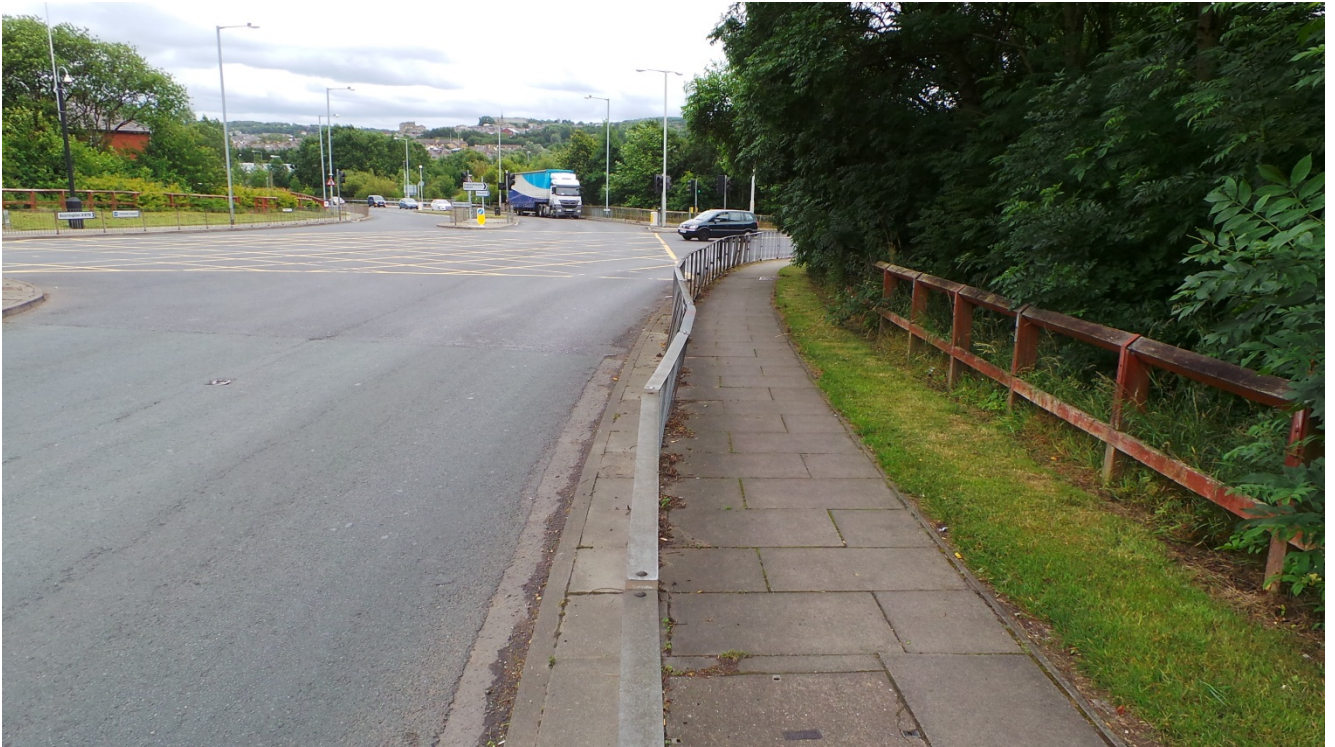
Figure A.3 : Damaged pedestrian guardrail on northbound Dunkenhalgh Way

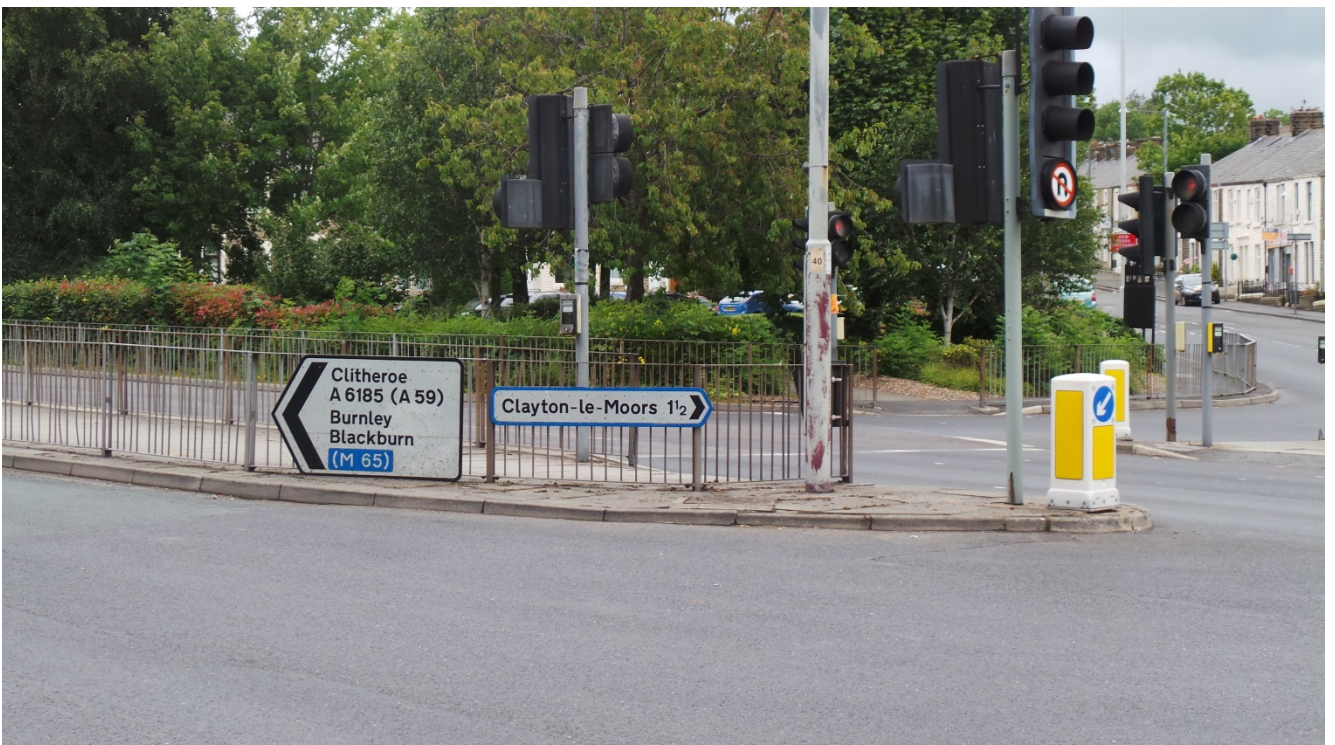
There are advance stack and flag type signs located around the junction which would benefit from being reviewed, with regard to the most appropriate location to mount them. Furthermore it was observed a number of signs would benefit from being consolidated. It was also noted that certain signs (Church and Clayton-le-moors) still have the old blue border, which require replacing to conform to current standards.

Figure A.4 : Flag type direction signs requiring renewal

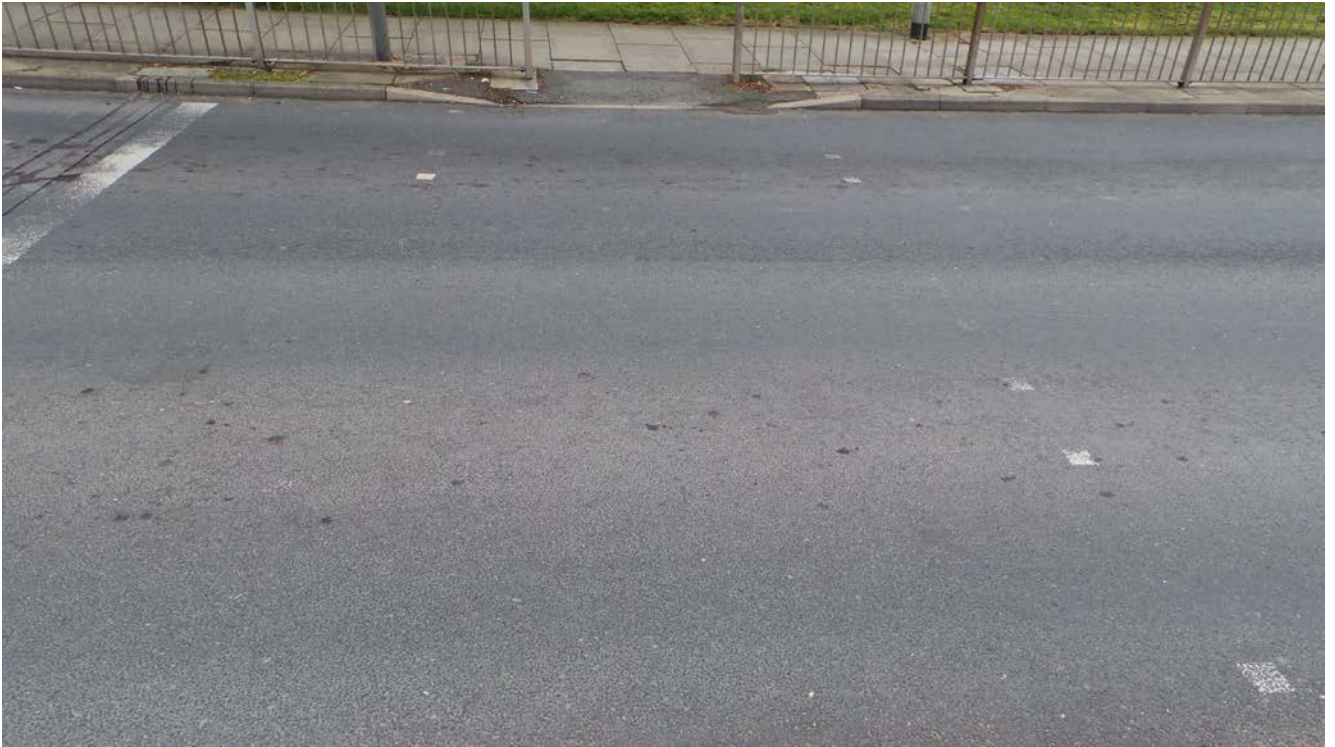
It is observed that lining at the junction is in need of refurbishment; in particular the crossing studs are worn.

Figure A.5 : Photograph showing existing worn studs to be refurbished

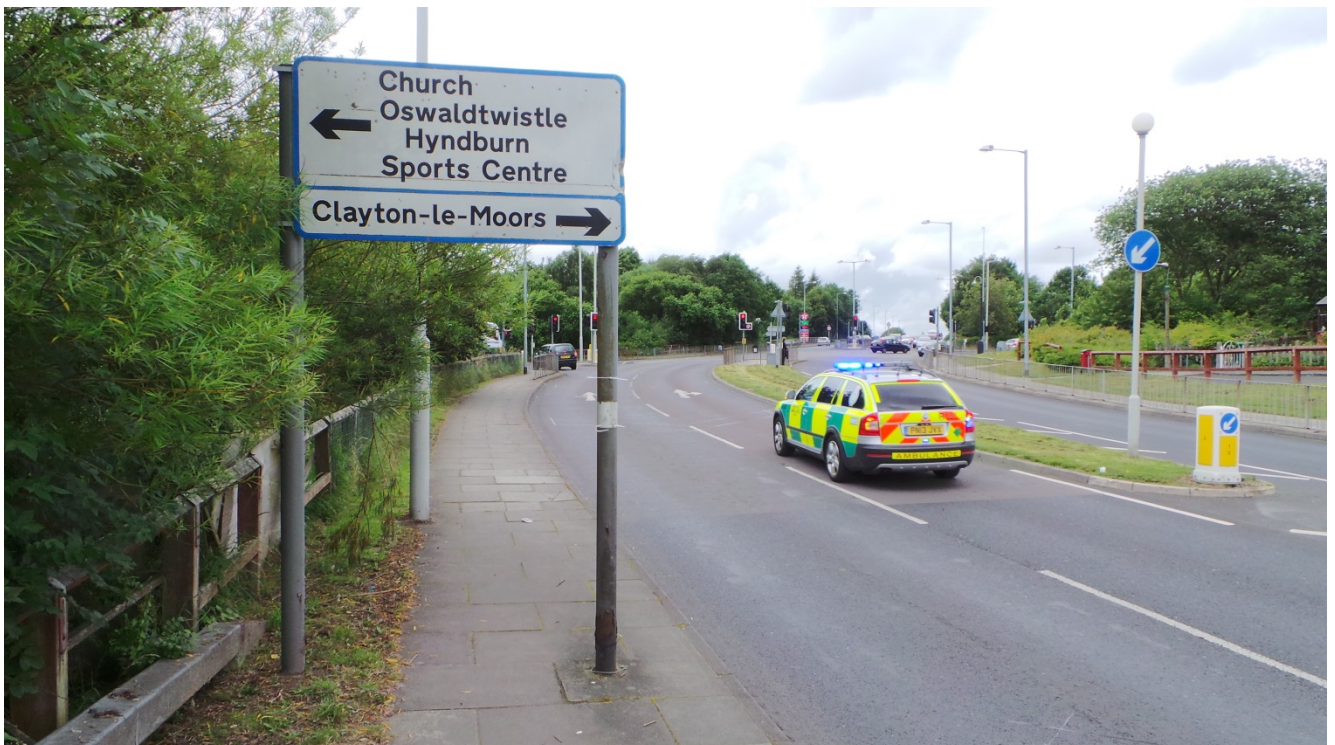
Figure A.6 : Advanced Direction Sign (ADS) requiring renewal on the northbound approach to the crossroads

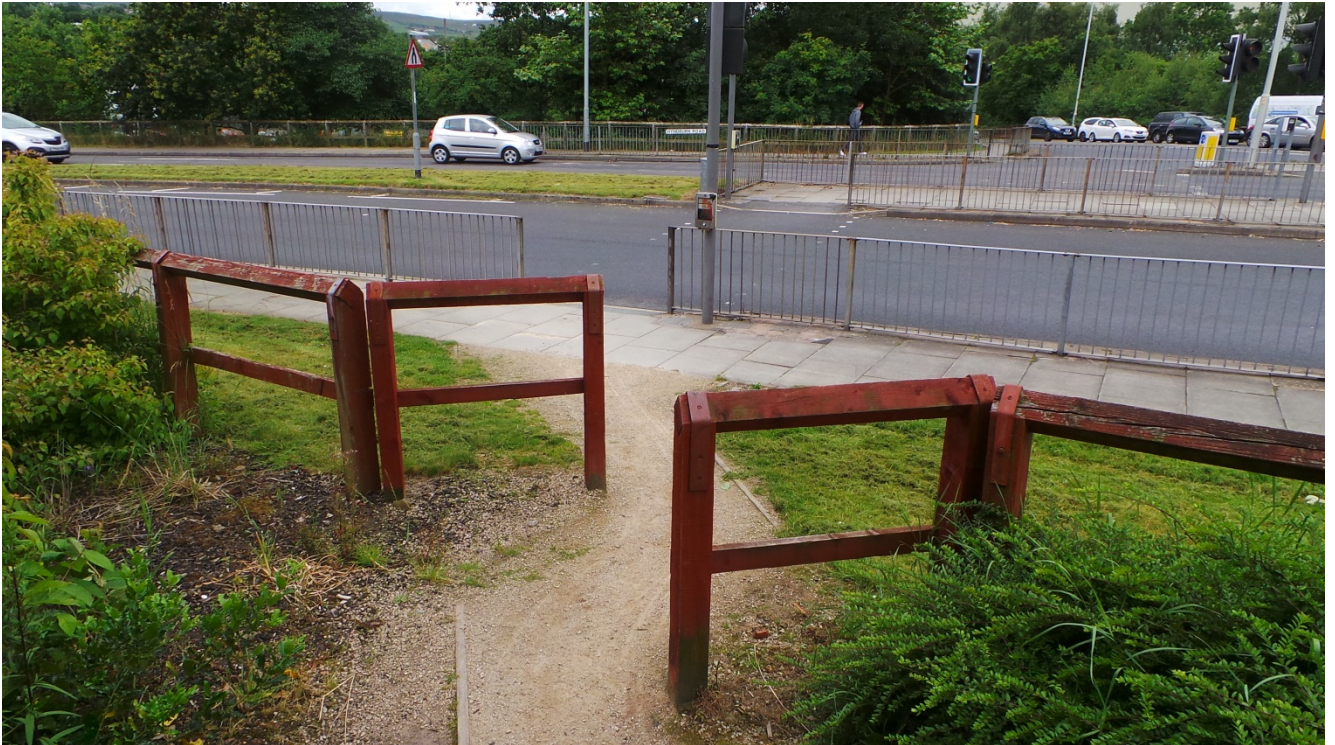
There is a footpath which leads from the vicinity of the electrical substation on Jubilee Road to the eastern crossing point of Hyndburn Road, which has a staggered fence in order to slow pedestrians and cyclists as they approach the crossing and Hyndburn Road. It is recommended that the stagger is adjusted to make the passage of cyclists more difficult in order to slow them down, so that they do not pass through the access too quickly and overshoot onto Hyndburn Road.

Figure A.7 : Staggered railing which allows easy passage for cyclists on approach to the pedestrian crossing on Hyndburn Road

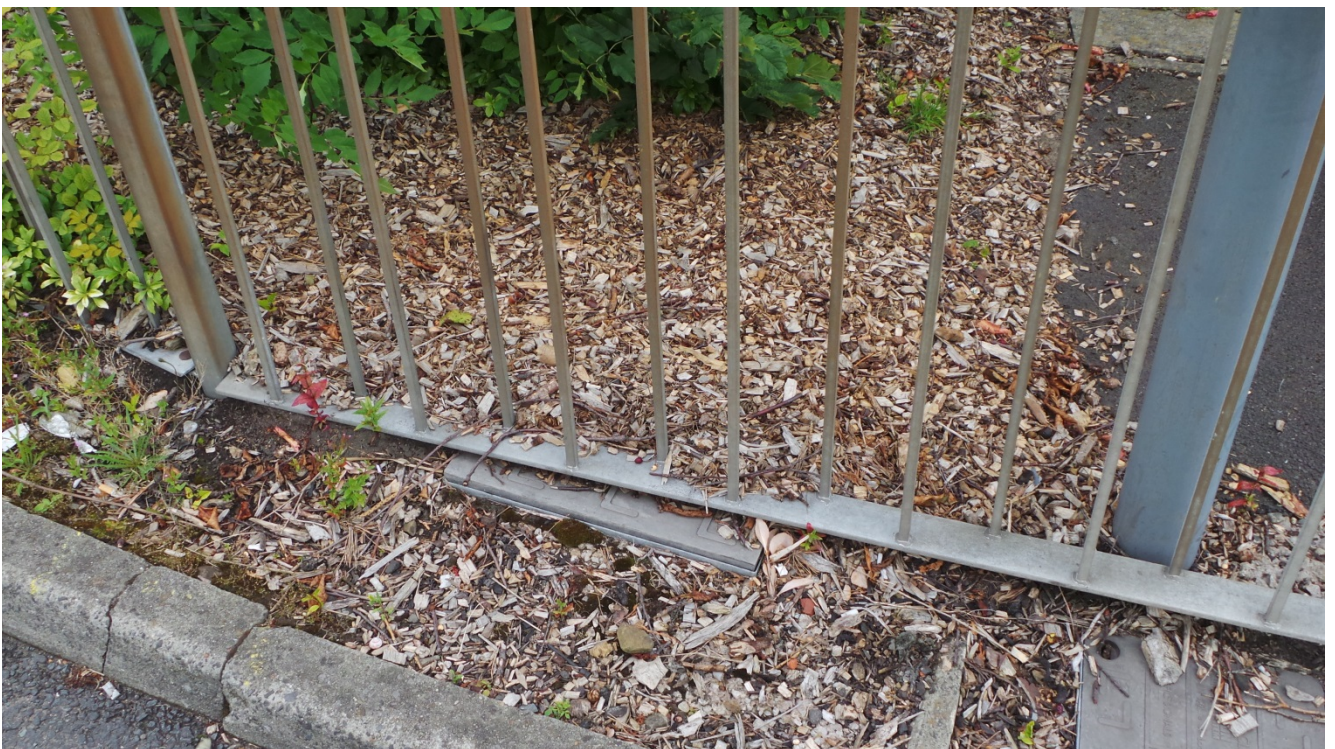
It is observed that a section of guard rail located in the verge, on the northern corner of the junction, between Dunkenhagh Road and Manor Place, straddles a service cover thereby preventing it being lifted easily. It is recommended that a section of bespoke railing is provided to mitigate this issue as part of the detailed design.

Figure A.8 : Pedestrian guardrail which restricts access to signal chamber, in the verge of the north-eastern corner of the crossroads
